Access Compliance Report

Public Rights-of-Way

(Curb Ramps)

Intersection ID: 18818	Main Street: BEAM_RD	Cross Street: SHOPTON_RD	Location: SE
ADA ID: E6E94E192B3B	Ramp Type: Perp	Initial Pass/Fail: Pass	Overall Compliance: No
Severity Score: 15			
Codes/Mitigation Info/Possible Solution		Field Measurements/Component Compliance

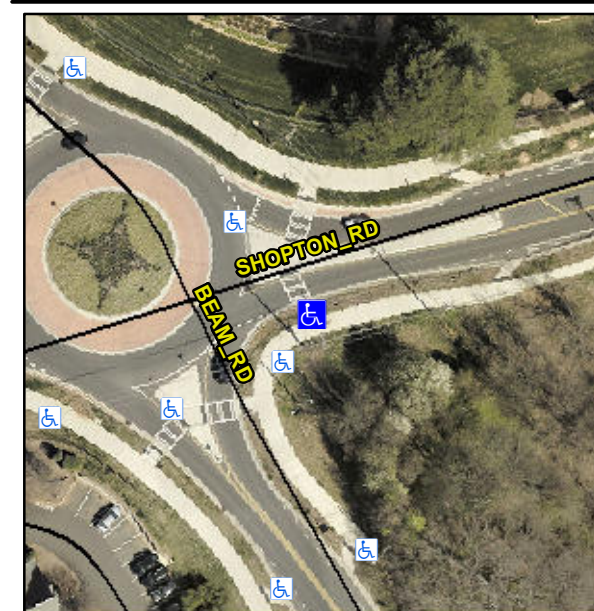
Compliance	Description	Data	Compliance	Description	Data
N/A	Ramp Length (in)	105.0	Yes	Ramp Slope (%)	6.3
Yes	Ramp Width (in)	95.0	Yes	Ramp XSlope (%)	1.9
N/A	Flare Type LT	None	N/A	Flare Type RT	N/A
N/A	Flare Slope LT (%)	N/A	N/A	Flare Slope RT (%)	N/A
N/A	Flare Traversable LT?	N/A	N/A	Flare Traversable RT?	N/A
Yes	Landing Length (in)	120.0	No	DWS Provided?	No
Yes	Landing Width (in)	95.0	N/A	DWS Contrast?	No
Yes	Landing Slope (%)	1.9	N/A	DWS Length (in)	N/A
Yes	Landing X Slope (%)	1.3	N/A	DWS Full Width?	No
N/A	Landing Curb? (Y/N)	No	N/A	DWS Offset (in)	N/A
N/A	Shared Landing?	No			
Yes	Gutter Ponding?	No	No	Gutter Slope (%)	5.2
Yes	Gutter Lip Ht (in)	0.0	Yes	Gutter X Slope (%)	0.5
N/A	Painted X Walk1?	Yes	N/A	Painted X Walk2?	N/A
	X Walk 1 Direction	To N		X Walk 2 Direction	N/A
N/A	X Walk 1 Width (in)	110.0	N/A	X Walk 2 Width (in)	N/A
	X Walk 1 Slope (%)	3.2		X Walk 2 Slope (%)	N/A
	X Walk 1 X Slope (%)	1.5		X Walk 2 X Slope (%)	N/A

Yes	Ramp inside XWalk1?	Yes	N/A	Ramp inside XWalk2?	N/A
	Road Slope (%)	N/A	N/A	Clear Space?	Yes
	Road X Slope (%)	N/A	N/A	Clear Space to XWalk (in)	N/A
Yes	Any Obstructions?	No	Yes	Storm Grate/Utility Hazard?	No
	Obstruction Type			Storm Grate/Utility Type	
		N/A			N/A
			Yes	Surface Condition? (G/P)	Good

Possible Solutions:

**Install Detectable Warning System.
Remove & Replace Gutter.**

R305, R304.5.4
