Access Compliance Report

Public Rights-of-Way

(Curb Ramps)

Intersection ID: 10028048	Main Street: HARTFORD_AV	Cross Street: N/A	Location: SE
ADA ID: E6EE7DA96237	Ramp Type: ParaDiag	Initial Pass/Fail: Fail	Overall Compliance: No
Codes/Mitigation Info/Possible Solution		Field Measurements/Component Compliance	
Severity Score: 26.25

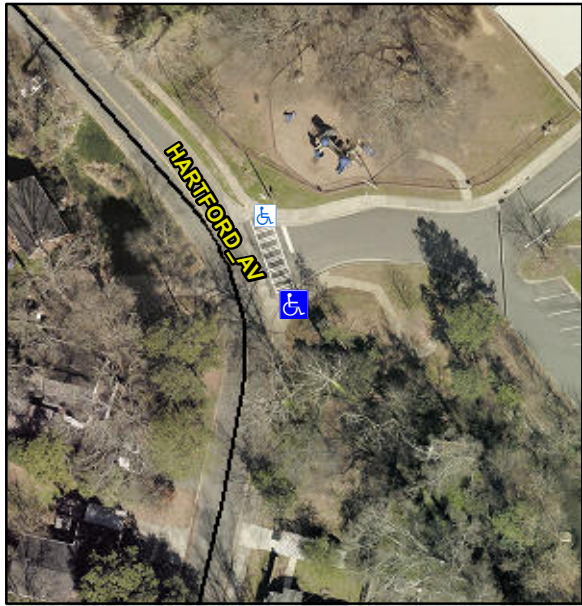
RT RP < 5%

R304.3.2, R304.5.3

Compliance	Description	Data	Compliance	Description	Data
N/A	Ramp Length LT (in)	65.0	N/A	Ramp Length RT (in)	47.0
Yes	Ramp Width LT (in)	82.0	Yes	Ramp Width RT (in)	82.0
No	Ramp Slope LT (%)	13.2	Yes	Ramp Slope RT (%)	1.4
Yes	Ramp XSlope LT (%)	0.8	No	Ramp XSlope RT (%)	2.9
N/A	Landing Length (in)	N/A	N/A	DWS Provided?	N/A
N/A	Landing Width (in)	N/A	N/A	DWS Contrast?	N/A
N/A	Landing Slope (%)	N/A	N/A	DWS Length (in)	N/A
N/A	Landing X Slope (%)	N/A	N/A	DWS Full Width?	N/A
N/A	Landing Curb? (Y/N)	N/A	N/A	DWS Offset (in)	N/A
N/A	Shared Landing?	N/A			
N/A	Gutter Ponding?	N/A	N/A	Gutter Slope (%)	N/A
N/A	Gutter Lip Ht (in)	1.0	N/A	Gutter X Slope (%)	N/A
N/A	Painted X Walk1?	Yes	N/A	Painted X Walk2?	No
	X Walk 1 Direction	To N		X Walk 2 Direction	To W
N/A	X Walk 1 Width (in)	110.0	N/A	X Walk 2 Width (in)	N/A
	X Walk 1 Slope (%)	2.1		X Walk 2 Slope (%)	6.2
	X Walk 1 X Slope (%)	7.1		X Walk 2 X Slope (%)	2.6
N/A	Ramp inside XWalk1?	Yes	N/A	Ramp inside XWalk2?	N/A

Road Slope (%)	6.7	N/A	Clear Space?	N/A
	Road X Slope (%)	5.8	N/A	Clear Space to XWalk (in)	N/A
N/A	Any Obstructions?	N/A	N/A	Storm Grate/Utility Hazard?	N/A
	Obstruction Type			Storm Grate/Utility Type	
		N/A			N/A
			Yes	Surface Condition? (G/P)	Good
			N/A	Curb Slope (%)	3.4

Remove & Replace Curb Ramp With Two New Directional Ramps or Equivalent.
