Access Compliance Report

Public Rights-of-Way

(Curb Ramps)

Intersection ID: 18778	Main Street: INDEPENDENCE_BV	Cross Street: N/A	Location: W
ADA ID: E6F7376F309E	Ramp Type: Perp	Initial Pass/Fail: Fail	Overall Compliance: No
Severity Score: 12.5			
Codes/Mitigation Info/Possible Solution		Field Measurements/Component Compliance

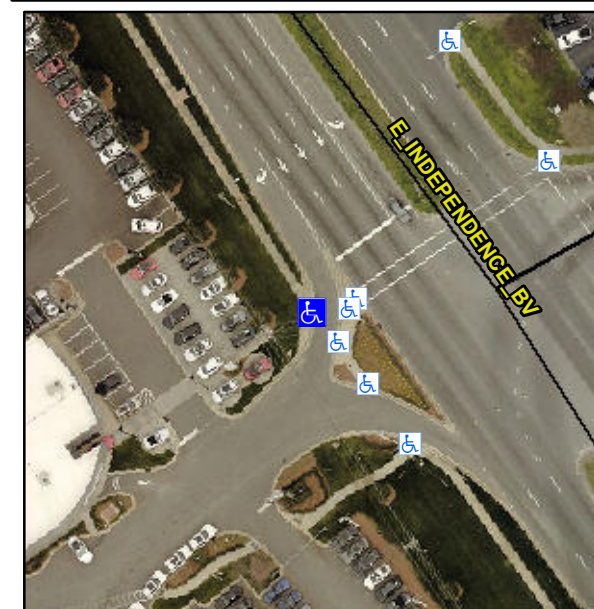
Not Found, R304.2.2

Compliance	Description	Data	Compliance	Description	Data
N/A	Ramp Length (in)	31.0	No	Ramp Slope (%)	9.5
Yes	Ramp Width (in)	48.0	Yes	Ramp XSlope (%)	0.4
N/A	Flare Type LT	N/A	N/A	Flare Type RT	N/A
N/A	Flare Slope LT (%)	N/A	N/A	Flare Slope RT (%)	N/A
N/A	Flare Traversable LT?	N/A	N/A	Flare Traversable RT?	N/A
N/A	Landing Length (in)	N/A	N/A	DWS Provided?	N/A
N/A	Landing Width (in)	N/A	N/A	DWS Contrast?	N/A
N/A	Landing Slope (%)	N/A	N/A	DWS Length (in)	N/A
N/A	Landing X Slope (%)	N/A	N/A	DWS Full Width?	N/A
N/A	Landing Curb? (Y/N)	N/A	N/A	DWS Offset (in)	N/A
N/A	Shared Landing?	N/A			
N/A	Gutter Ponding?	N/A	N/A	Gutter Slope (%)	N/A
N/A	Gutter Lip Ht (in)	N/A	N/A	Gutter X Slope (%)	N/A
N/A	Painted X Walk1?	No	N/A	Painted X Walk2?	N/A
	X Walk 1 Direction	To SE		X Walk 2 Direction	N/A
N/A	X Walk 1 Width (in)	N/A	N/A	X Walk 2 Width (in)	N/A
	X Walk 1 Slope (%)	0.8		X Walk 2 Slope (%)	N/A
	X Walk 1 X Slope (%)	0.8		X Walk 2 X Slope (%)	N/A

N/A	Ramp inside XWalk1?	N/A	N/A	Ramp inside XWalk2?	N/A
	Road Slope (%)	N/A	N/A	Clear Space?	N/A
	Road X Slope (%)	N/A	N/A	Clear Space to XWalk (in)	N/A
N/A	Any Obstructions?	N/A	N/A	Storm Grate/Utility Hazard?	N/A
	Obstruction Type			Storm Grate/Utility Type	
		N/A			N/A
			Yes	Surface Condition? (G/P)	Good

Remove & Replace Entire Ramp.
