Access Compliance Report Public Rights-of-Way (Curb Ramps)

Intersection ID: 10024552 Main Street: D DUCKS LN **Cross Street: N/A** Location:

Initial Pass/Fail: Fail ADA ID: E70079F09AF9 Ramp Type: BlendTrans1 **Overall Compliance: No** Severity Score: 33.75

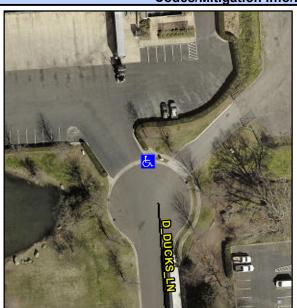
Field Measure	ments/C	ompo	nent C	Compliance	
	Compliance Description		Data	Compliance		Description	Data
	N/A	Ramp Length (in)	47.0	Yes	Blend	dTrans Slope (%)	4.4
	No	Ramp Width (in)	41.0	No	Blend	dTrans XSlope (%)	7.2
	N/A	Flare Type LT	N/A	N/A	Flare	Type RT	N/A
	N/A	Flare Slope LT (%)	N/A	N/A	Flare	Slope RT (%)	N/A
	N/A	Flare Traversable LT?	N/A	N/A	Flare	Traversable RT?	N/A
	N/A	Landing Length (in)	N/A	N/A	DWS	Provided?	N/A
	N/A	Landing Width (in)	N/A	N/A	DWS	Contrast?	N/A
	N/A	Landing Slope (%)	N/A	N/A	DWS	Length (in)	N/A
	N/A	Landing X Slope (%)	N/A	N/A	DWS	Full Width?	N/A
	N/A	Landing Curb? (Y/N)	N/A	N/A	DWS	Offset (in)	N/A
	N/A	Shared Landing?	N/A				
	N/A	Gutter Ponding?	N/A	N/A	Gutte	er Slope (%)	N/A
	N/A	Gutter Lip Ht (in)	N/A	N/A	Gutte	er X Slope (%)	N/A
	N/A	Painted X Walk1?	No	N/A	Paint	ed X Walk2?	N/A
		X Walk 1 Direction	To SW		X Wa	ılk 2 Direction	N/A
		X Walk 1 Width (in)	N/A		X Wa	ılk 2 Width (in)	N/A

X Walk 1 Slope (%)	0.4		X Wa	ılk 2 Slope (%)	N/A
		X Walk 1 X Slope (%)	4.1		X Wa	ılk 2 X Slope (%)	N/A
	N/A	Ramp inside XWalk1?	N/A	N/A	Ramı	p inside XWalk2?	N/A
		Road Slope (%)	4.1		Clear	Space?	N/A
		Road X Slope (%)	0.4	N/A	Clear	Space to XWalk (in)	N/A
	N/A	Any Obstructions?	N/A	N/A	Storn	n Grate/Utility Hazard?	N/A
		Obstruction Type			Storn	n Grate/Utility Type	
			N/A				N/A
				Yes	Surfa	ice Condition? (G/P)	Good
No.		HOTELS AND THE STATE OF THE STA		N/A	Curb	Slope (%)	2.8

Possible Solutions: Remove & Replace Curb Ramp With **Two New Directional Ramps or** Equivalent. Surveyor Notes: N/A

R304.5.1, R304.5.3
