Access Compliance Report

Public Rights-of-Way

(Curb Ramps)

Intersection ID: 12850	Main Street: CONNELLY_CR	Cross Street: MORRIS_FIELD_DR	Location: NW
ADA ID: E703C56B3253	Ramp Type: Directional1	Initial Pass/Fail: Fail	Overall Compliance: No
Severity Score: 1.25			
Codes/Mitigation Info/Possible Solution		Field Measurements/Component Compliance

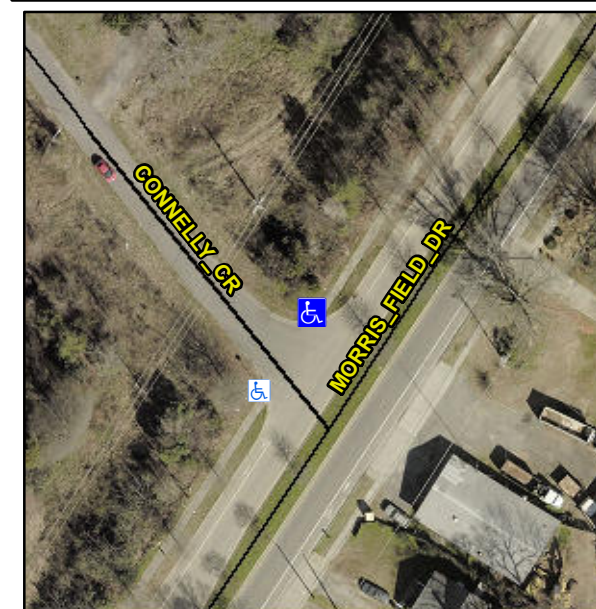
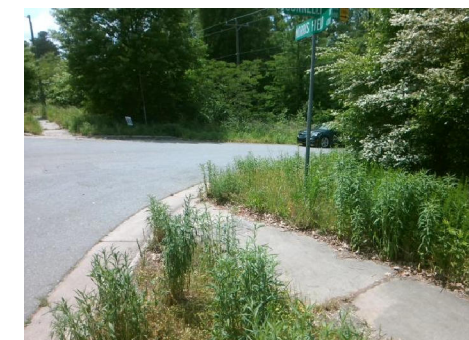
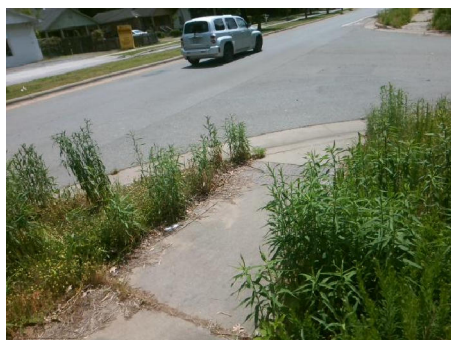
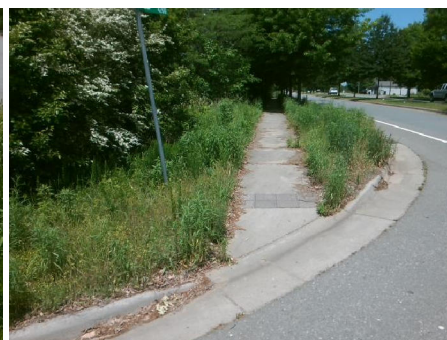
Compliance	Description	Data	Compliance	Description	Data
N/A	Ramp Length (in)	34.0	N/A	Grade Break?	N/A
Yes	Ramp Width (in)	60.0	N/A	Grade Break Slope (%)	0.0
Yes	Ramp Slope (%)	5.5	N/A	Grade Break XSlope (%)	0.0
No	Ramp XSlope (%)	2.6			
N/A	Flare Type LT	N/A	N/A	Flare Type RT	N/A
N/A	Flare Slope LT (%)	N/A	N/A	Flare Slope RT (%)	0.0
N/A	Flare Traversable LT?	N/A	N/A	Flare Traversable RT?	N/A
N/A	Landing Length (in)	0.0	N/A	DWS Provided?	N/A
N/A	Landing Width (in)	0.0	N/A	DWS Contrast?	N/A
N/A	Landing Slope (%)	0.0	N/A	DWS Length (in)	N/A
N/A	Landing X Slope (%)	0.0	N/A	DWS Full Width?	N/A
N/A	Landing Curb? (Y/N)	N/A	N/A	DWS Offset LT (in)	N/A
N/A	Shared Landing?	N/A	N/A	DWS Offset RT (in)	N/A
N/A	Gutter Ponding?	0.0	N/A	Gutter Slope (%)	N/A
N/A	Gutter Lip Ht (in)	0.0	N/A	Gutter X Slope (%)	N/A
N/A	Painted X Walk1?	No		Road Slope (%)	2.2
	X Walk 1 Direction	To S		Road X Slope (%)	9.0
	X Walk 1 Width (in)	N/A		Clear Space?	N/A

X Walk 1 Slope (%)	2.2	N/A	Clear Space to XWalk (in)	N/A
	X Walk 1 X Slope (%)	9.0	N/A	Storm Grate/Utility Hazard?	N/A
N/A	Ramp inside XWalk1?	N/A		Storm Grate/Utility Type	
N/A	Any Obstructions?	N/A			N/A
	Obstruction Type		Yes	Surface Condition? (G/P)	Good
			N/A	Curb Slope (%)	3.0

Possible Solutions:

Remove & Replace Entire Ramp.

Total Cost: \$ 1600.00
