# Access Compliance Report

## Public Rights-of-Way

### (Curb Ramps)

Intersection ID: 19518	Main Street: CARYSBROOK_LN	Cross Street: CHERRYCREST_LN	Location: SE
ADA ID: E7043D873F75	Ramp Type: PerpDiag	Initial Pass/Fail: Fail	Overall Compliance: No
Severity Score: 25			
Codes/Mitigation Info/Possible Solution		Field Measurements/Component Compliance

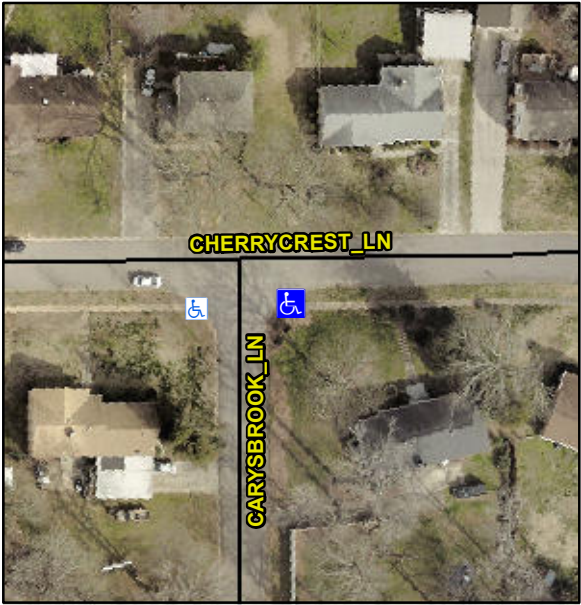
Possible Solutions:		Compliance	Description	Data	Compliance	Description	Data
	Remove & Replace Curb Ramp With Two New Directional Ramps or Equivalent.		N/A	Ramp Length (in)	48.0	No	Ramp Slope (%)	8.7

Surveyor Notes:		Yes	Ramp Width (in)	48.0	No	Ramp XSlope (%)	5.1
	N/A		N/A	Flare Type LT	N/A	N/A	Flare Type RT	N/A

PROW/ADA:		N/A	Flare Slope LT (%)	N/A	N/A	Flare Slope RT (%)	N/A
	Not Found, R304.2.2, R304.5.3		N/A	Flare Traversable LT?	N/A	N/A	Flare Traversable RT?	N/A
