# Access Compliance Report

## Public Rights-of-Way

### (Curb Ramps)

Intersection ID: 15576	Main Street: LAWYERS_RD	Cross Street: IDLEWILD_RD_NORTH	Location: SW
ADA ID: E709719396FA	Ramp Type: PerpDiag	Initial Pass/Fail: Fail	Overall Compliance: No
			Severity Score: 21.25

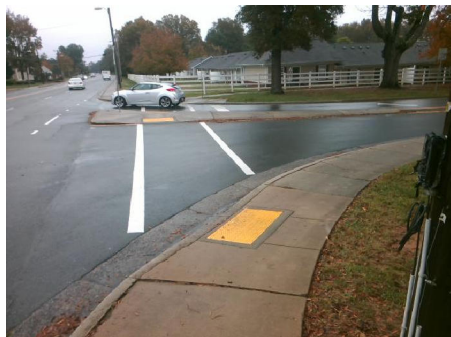
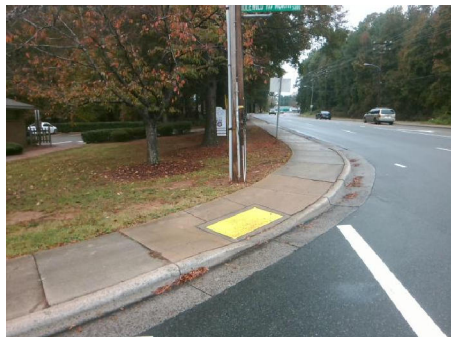
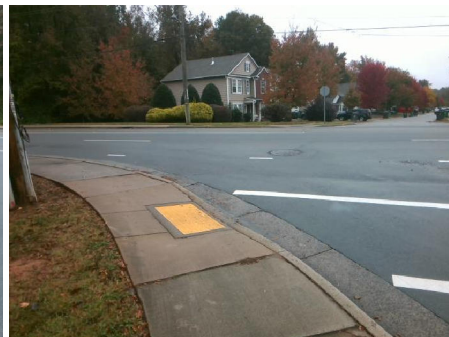
**Not Found, R304.5.1, R304.5.3**

Compliance	Description	Data	Compliance	Description	Data
N/A	Ramp Length (in)	59.0	Yes	Ramp Slope (%)	5.9
No	Ramp Width (in)	37.0	No	Ramp XSlope (%)	6.2
N/A	Flare Type LT	N/A	N/A	Flare Type RT	N/A
N/A	Flare Slope LT (%)	N/A	N/A	Flare Slope RT (%)	N/A
N/A	Flare Traversable LT?	N/A	N/A	Flare Traversable RT?	N/A
N/A	Landing Length (in)	N/A	N/A	DWS Provided?	N/A
N/A	Landing Width (in)	N/A	N/A	DWS Contrast?	N/A
N/A	Landing Slope (%)	N/A	N/A	DWS Length (in)	N/A
N/A	Landing X Slope (%)	N/A	N/A	DWS Full Width?	N/A
N/A	Landing Curb? (Y/N)	N/A	N/A	DWS Offset (in)	N/A
N/A	Shared Landing?	N/A			
N/A	Gutter Ponding?	N/A	N/A	Gutter Slope (%)	N/A
N/A	Gutter Lip Ht (in)	N/A	N/A	Gutter X Slope (%)	N/A
N/A	Painted X Walk1?	Yes	N/A	Painted X Walk2?	No
	X Walk 1 Direction	To SE		X Walk 2 Direction	To NE
N/A	X Walk 1 Width (in)	85.0	N/A	X Walk 2 Width (in)	N/A
	X Walk 1 Slope (%)	0.8		X Walk 2 Slope (%)	6.8
	X Walk 1 X Slope (%)	9.1		X Walk 2 X Slope (%)	0.1

N/A	Ramp inside XWalk1?	Yes	N/A	Ramp inside XWalk2?	N/A
	Road Slope (%)	6.2	N/A	Clear Space?	N/A
	Road X Slope (%)	6.5	N/A	Clear Space to XWalk (in)	N/A
N/A	Any Obstructions?	N/A	N/A	Storm Grate/Utility Hazard?	N/A
	Obstruction Type			Storm Grate/Utility Type	
		N/A			N/A
		Yes		Surface Condition? (G/P)	Good

**Remove & Replace Curb Ramp With Two New Directional Ramps or Equivalent.**
