## **Access Compliance Report Public Rights-of-Way** (Curb Ramps)

Intersection ID: 10024487 Main Street: CROWN CENTRE DR **Cross Street: N/A** Location: ADA ID: E70E3FEB87F0 Ramp Type: PerpDiag Initial Pass/Fail: Fail **Overall Compliance: No** Severity Score: 21.25

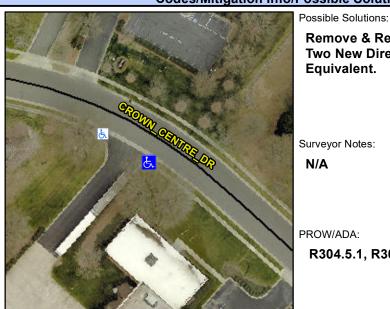
R304.5.1, R304.2.2

Compliance Description Data		Comp	liance Description	Data	
N/A	Ramp Length (in)	110.0	No	Ramp Slope (%)	8.4
No	Ramp Width (in)	46.0	Yes	Ramp XSlope (%)	0.5
N/A	Flare Type LT	N/A	N/A	Flare Type RT	N/A
N/A	Flare Slope LT (%)	N/A	N/A	Flare Slope RT (%)	N/A
N/A	Flare Traversable LT?	N/A	N/A	Flare Traversable RT?	N/A
N/A	Landing Length (in)	N/A	N/A	DWS Provided?	N/A
N/A	Landing Width (in)	N/A	N/A	DWS Contrast?	N/A
N/A	Landing Slope (%)	N/A	N/A	DWS Length (in)	N/A
N/A	Landing X Slope (%)	N/A	N/A	DWS Full Width?	N/A
N/A	Landing Curb? (Y/N)	N/A	N/A	DWS Offset (in)	N/A
N/A	Shared Landing?	N/A			
N/A	Gutter Ponding?	N/A	N/A	Gutter Slope (%)	N/A
N/A	Gutter Lip Ht (in)	0.5	N/A	Gutter X Slope (%)	N/A
N/A	Painted X Walk1?	No	N/A	Painted X Walk2?	No
	X Walk 1 Direction	To NE		X Walk 2 Direction	To NW
N/A	X Walk 1 Width (in)	N/A	N/A	X Walk 2 Width (in)	N/A
	X Walk 1 Slope (%)	4.9		X Walk 2 Slope (%)	0.3
	X Walk 1 X Slope (%)	1.1		X Walk 2 X Slope (%)	4.3

N/A	Ramp inside XWalk1?	N/A	N/A	Ramp inside XWalk2?	N/A
	Road Slope (%)	0.5	N/A	Clear Space?	N/A
	Road X Slope (%)	1.9	N/A	Clear Space to XWalk (in)	N/A
N/A	Any Obstructions?	N/A	N/A	Storm Grate/Utility Hazard?	N/A
	Obstruction Type		l	Storm Grate/Utility Type	
		N/A			N/A
			Yes	Surface Condition? (G/P)	Good

Remove & Replace Curb Ramp With **Two New Directional Ramps or** Equivalent.

Total Cost: 3200.00
