# Access Compliance Report Public Rights-of-Way (Curb Ramps)

| Intersection ID: N/A | Main Street: MORABLIN_DR | Cross Street: MERSINGTON_LN | Location: NE |
| ADA ID: E712FD2A0DDA | Ramp Type: PerpDiag | Initial Pass/Fail: Pass | Overall Compliance: No<br>Severity Score: 15 |

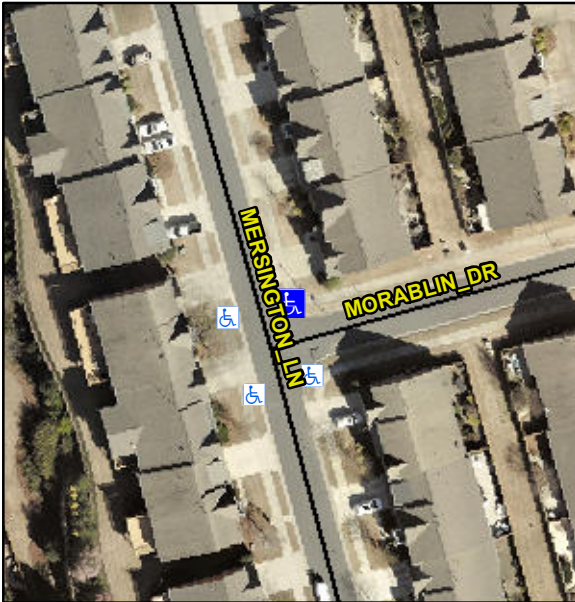
| Compliance | Description | Data | Compliance | Description | Data |
|---|---|---|---|---|---|
| Yes | Landing Length (in) | 59.0 | No | DWS Provided? | No |
| No | Landing Slope (%) | 3.8 | N/A | DWS Length (in) | N/A |
| Yes | Gutter Ponding? | No | No | Gutter Slope (%) | 6.4 |

**Remove & Replace Curb Ramp With Two New Directional Ramps or Equivalent. Remove & Replace Gutter.**

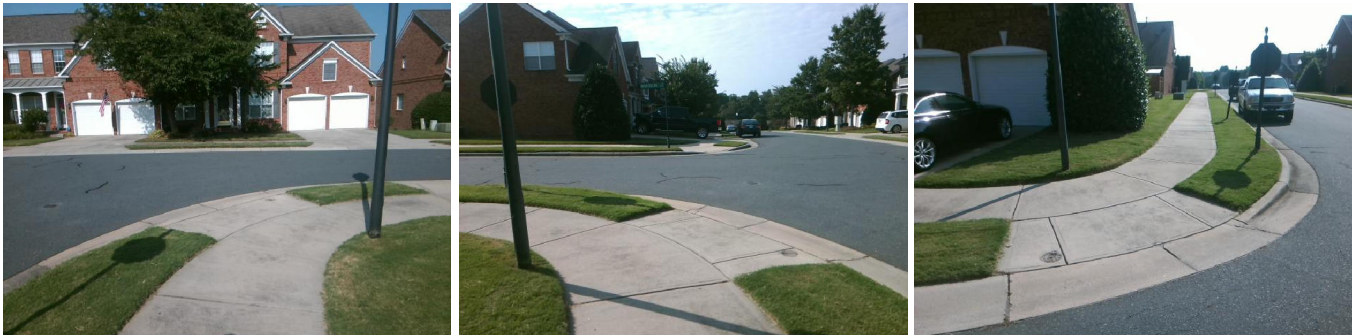
Street 1 Name: MERSINGTON LN  
 Stop Condition-Street 2: None  
 Street 2 Name: MORABLIN DR  
 Stop Condition-Street 1: StopSign
