# Access Compliance Report

## Public Rights-of-Way

### (Curb Ramps)

Intersection ID: 29723	Main Street: LANNIER_FALLS_LN	Cross Street: MEDOC_MOUNTAIN_DR	Location: S
ADA ID: E7136CE72993	Ramp Type: Perp	Initial Pass/Fail: Fail	Overall Compliance: No
Severity Score: 8.75			
Codes/Mitigation Info/Possible Solution		Field Measurements/Component Compliance

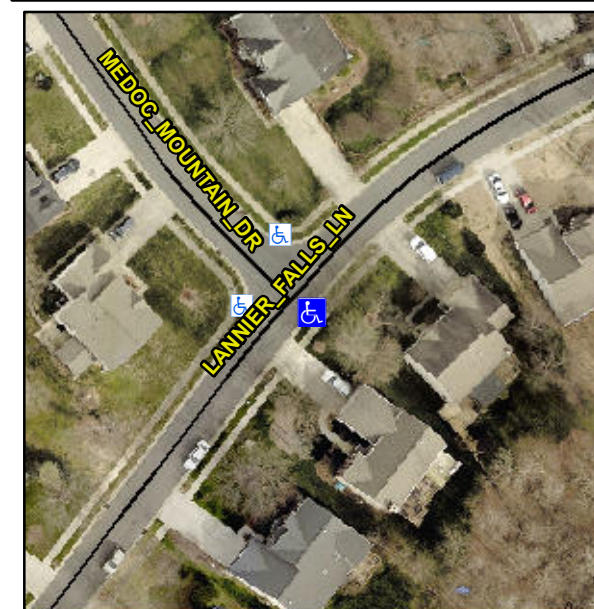
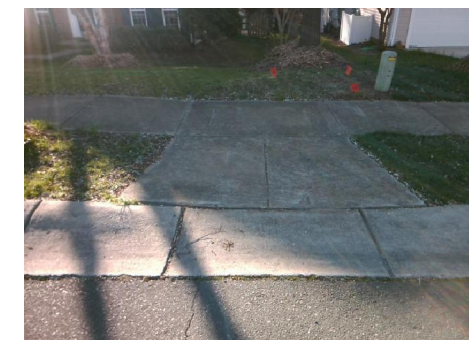
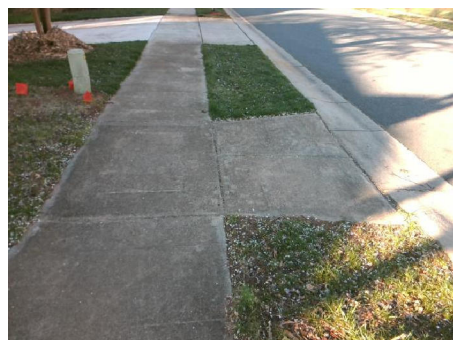
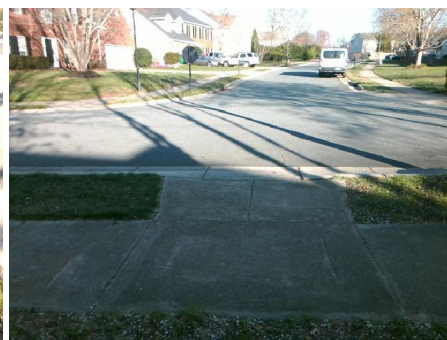
Compliance	Description	Data	Compliance	Description	Data
N/A	Ramp Length (in)	48.5	Yes	Ramp Slope (%)	3.5
No	Ramp Width (in)	47.0	Yes	Ramp XSlope (%)	1.4
N/A	Flare Type LT	N/A	N/A	Flare Type RT	N/A
N/A	Flare Slope LT (%)	N/A	N/A	Flare Slope RT (%)	N/A
N/A	Flare Traversable LT?	N/A	N/A	Flare Traversable RT?	N/A
N/A	Landing Length (in)	N/A	N/A	DWS Provided?	N/A
N/A	Landing Width (in)	N/A	N/A	DWS Contrast?	N/A
N/A	Landing Slope (%)	N/A	N/A	DWS Length (in)	N/A
N/A	Landing X Slope (%)	N/A	N/A	DWS Full Width?	N/A
N/A	Landing Curb? (Y/N)	N/A	N/A	DWS Offset (in)	N/A
N/A	Shared Landing?	N/A			
N/A	Gutter Ponding?	N/A	N/A	Gutter Slope (%)	N/A
N/A	Gutter Lip Ht (in)	N/A	N/A	Gutter X Slope (%)	N/A
N/A	Painted X Walk1?	No	N/A	Painted X Walk2?	N/A
	X Walk 1 Direction	To N		X Walk 2 Direction	N/A
N/A	X Walk 1 Width (in)	N/A	N/A	X Walk 2 Width (in)	N/A
	X Walk 1 Slope (%)	0.9		X Walk 2 Slope (%)	N/A
	X Walk 1 X Slope (%)	3.1		X Walk 2 X Slope (%)	N/A

N/A	Ramp inside XWalk1?	N/A	N/A	Ramp inside XWalk2?	N/A
	Road Slope (%)	N/A	N/A	Clear Space?	N/A
	Road X Slope (%)	N/A	N/A	Clear Space to XWalk (in)	N/A
N/A	Any Obstructions?	N/A	N/A	Storm Grate/Utility Hazard?	N/A
	Obstruction Type			Storm Grate/Utility Type	
		N/A			N/A
			Yes	Surface Condition? (G/P)	Good

Possible Solutions:

**Remove & Replace Entire Ramp.**

**R304.5.1**
