Access Compliance Report

Public Rights-of-Way

(Curb Ramps)

Intersection ID: 49803	Main Street: ATKINS_RIDGE_DR	Cross Street: MATARESE_CT	Location: W
ADA ID: E7160C590D8F	Ramp Type: Perp	Initial Pass/Fail: Fail	Overall Compliance: No
		Severity Score: 25

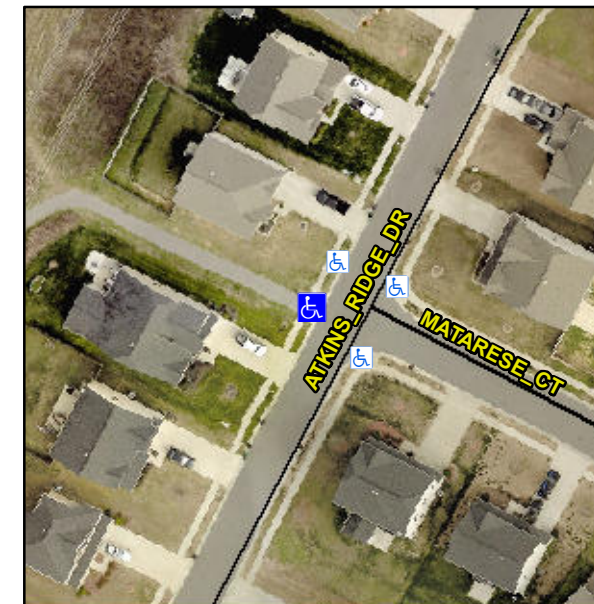
Not Found, R304.2.2, R304.5.3

Compliance	Description	Data	Compliance	Description	Data
N/A	Ramp Length (in)	47.0	No	Ramp Slope (%)	8.6
Yes	Ramp Width (in)	48.0	No	Ramp XSlope (%)	5.2
N/A	Flare Type LT	N/A	N/A	Flare Type RT	N/A
N/A	Flare Slope LT (%)	N/A	N/A	Flare Slope RT (%)	N/A
N/A	Flare Traversable LT?	N/A	N/A	Flare Traversable RT?	N/A
N/A	Landing Length (in)	N/A	N/A	DWS Provided?	N/A
N/A	Landing Width (in)	N/A	N/A	DWS Contrast?	N/A
N/A	Landing Slope (%)	N/A	N/A	DWS Length (in)	N/A
N/A	Landing X Slope (%)	N/A	N/A	DWS Full Width?	N/A
N/A	Landing Curb? (Y/N)	N/A	N/A	DWS Offset (in)	N/A
N/A	Shared Landing?	N/A			
N/A	Gutter Ponding?	N/A	N/A	Gutter Slope (%)	N/A
N/A	Gutter Lip Ht (in)	N/A	N/A	Gutter X Slope (%)	N/A
N/A	Painted X Walk1?	No	N/A	Painted X Walk2?	N/A
	X Walk 1 Direction	To SE		X Walk 2 Direction	N/A
N/A	X Walk 1 Width (in)	N/A	N/A	X Walk 2 Width (in)	N/A
	X Walk 1 Slope (%)	3.3		X Walk 2 Slope (%)	N/A
	X Walk 1 X Slope (%)	6.0		X Walk 2 X Slope (%)	N/A

Remove & Replace Entire Ramp.
