Access Compliance Report

Public Rights-of-Way

(Curb Ramps)

Intersection ID: 10036927	Main Street: S_SHARON_AMITY_RD	Cross Street: N/A	Location: NE
ADA ID: E72FC7C28278	Ramp Type: PerpDiag	Initial Pass/Fail: Fail	Overall Compliance: No
Severity Score: 25			
Codes/Mitigation Info/Possible Solution		Field Measurements/Component Compliance

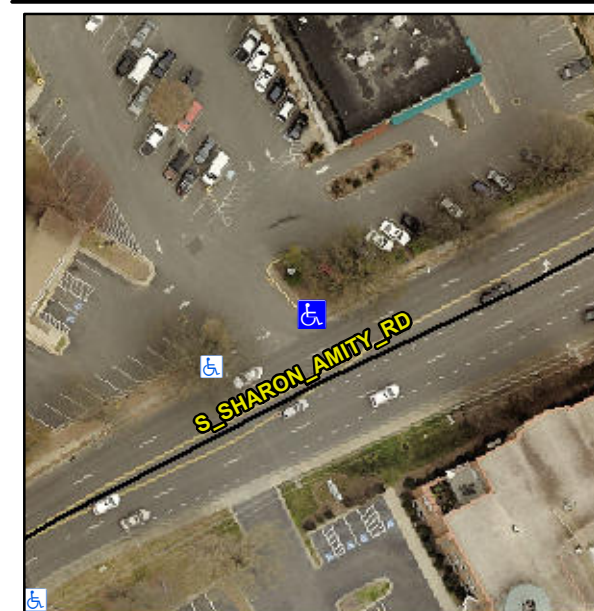
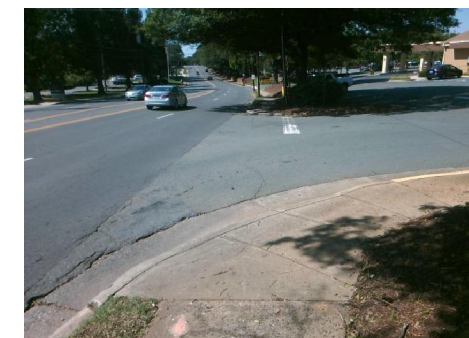
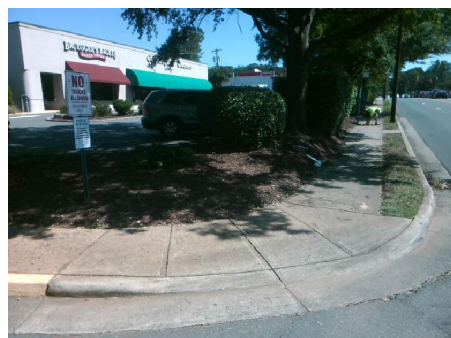
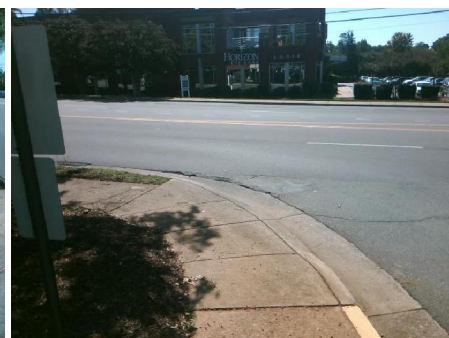
Not Found, R304.2.2

Compliance	Description	Data	Compliance	Description	Data
N/A	Ramp Length (in)	54.0	No	Ramp Slope (%)	12.3
Yes	Ramp Width (in)	67.0	Yes	Ramp XSlope (%)	1.2
N/A	Flare Type LT	N/A	N/A	Flare Type RT	N/A
N/A	Flare Slope LT (%)	N/A	N/A	Flare Slope RT (%)	N/A
N/A	Flare Traversable LT?	N/A	N/A	Flare Traversable RT?	N/A
N/A	Landing Length (in)	N/A	N/A	DWS Provided?	N/A
N/A	Landing Width (in)	N/A	N/A	DWS Contrast?	N/A
N/A	Landing Slope (%)	N/A	N/A	DWS Length (in)	N/A
N/A	Landing X Slope (%)	N/A	N/A	DWS Full Width?	N/A
N/A	Landing Curb? (Y/N)	N/A	N/A	DWS Offset (in)	N/A
N/A	Shared Landing?	N/A			
N/A	Gutter Ponding?	N/A	N/A	Gutter Slope (%)	N/A
N/A	Gutter Lip Ht (in)	N/A	N/A	Gutter X Slope (%)	N/A
N/A	Painted X Walk1?	No	N/A	Painted X Walk2?	No
	X Walk 1 Direction	To SW		X Walk 2 Direction	To SE
N/A	X Walk 1 Width (in)	N/A	N/A	X Walk 2 Width (in)	N/A
	X Walk 1 Slope (%)	0.6		X Walk 2 Slope (%)	0.9
	X Walk 1 X Slope (%)	0.8		X Walk 2 X Slope (%)	1.6

N/A	Ramp inside XWalk1?	N/A	N/A	Ramp inside XWalk2?	N/A
	Road Slope (%)	2.8	N/A	Clear Space?	N/A
	Road X Slope (%)	1.3	N/A	Clear Space to XWalk (in)	N/A
N/A	Any Obstructions?	N/A	N/A	Storm Grate/Utility Hazard?	N/A
	Obstruction Type			Storm Grate/Utility Type	
		N/A			N/A
			Yes	Surface Condition? (G/P)	Good

Remove & Replace Curb Ramp With Two New Directional Ramps or Equivalent.
