Access Compliance Report

Public Rights-of-Way

(Curb Ramps)

Intersection ID: 10018631	Main Street: AGAVA_LN	Cross Street: N/A	Location: SE
ADA ID: E7354F94EC2B	Ramp Type: Perp	Initial Pass/Fail: Fail	Overall Compliance: No
Severity Score: 21.25			
Codes/Mitigation Info/Possible Solution		Field Measurements/Component Compliance

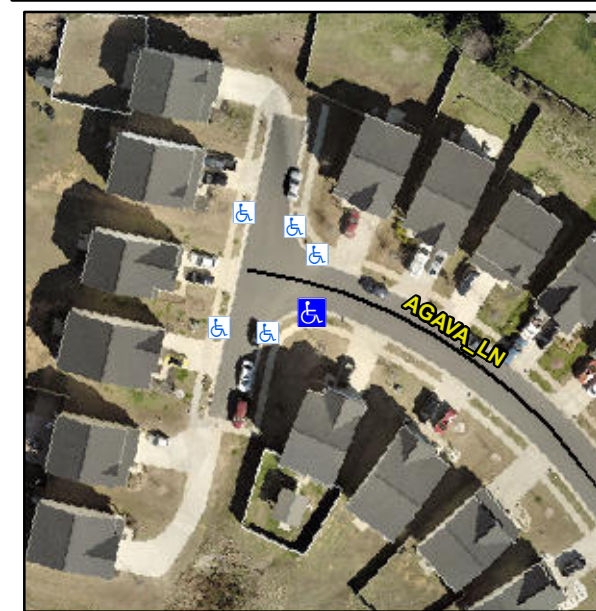
Not Found, R304.5.1, R304.5.3

Compliance	Description	Data	Compliance	Description	Data
N/A	Ramp Length (in)	49.0	Yes	Ramp Slope (%)	7.0
No	Ramp Width (in)	47.5	No	Ramp XSlope (%)	5.1
N/A	Flare Type LT	N/A	N/A	Flare Type RT	N/A
N/A	Flare Slope LT (%)	N/A	N/A	Flare Slope RT (%)	N/A
N/A	Flare Traversable LT?	N/A	N/A	Flare Traversable RT?	N/A
N/A	Landing Length (in)	N/A	N/A	DWS Provided?	N/A
N/A	Landing Width (in)	N/A	N/A	DWS Contrast?	N/A
N/A	Landing Slope (%)	N/A	N/A	DWS Length (in)	N/A
N/A	Landing X Slope (%)	N/A	N/A	DWS Full Width?	N/A
N/A	Landing Curb? (Y/N)	N/A	N/A	DWS Offset (in)	N/A
N/A	Shared Landing?	N/A			
N/A	Gutter Ponding?	N/A	N/A	Gutter Slope (%)	N/A
N/A	Gutter Lip Ht (in)	N/A	N/A	Gutter X Slope (%)	N/A
N/A	Painted X Walk1?	No	N/A	Painted X Walk2?	N/A
	X Walk 1 Direction	To N		X Walk 2 Direction	N/A
N/A	X Walk 1 Width (in)	N/A	N/A	X Walk 2 Width (in)	N/A
	X Walk 1 Slope (%)	0.2		X Walk 2 Slope (%)	N/A
	X Walk 1 X Slope (%)	4.2		X Walk 2 X Slope (%)	N/A

N/A	Ramp inside XWalk1?	N/A	N/A	Ramp inside XWalk2?	N/A
	Road Slope (%)	N/A	N/A	Clear Space?	N/A
	Road X Slope (%)	N/A	N/A	Clear Space to XWalk (in)	N/A
N/A	Any Obstructions?	N/A	N/A	Storm Grate/Utility Hazard?	N/A
	Obstruction Type			Storm Grate/Utility Type	
		N/A			N/A
			Yes	Surface Condition? (G/P)	Good

Possible Solutions:

Remove & Replace Entire Ramp.
