Access Compliance Report

Public Rights-of-Way

(Curb Ramps)

Intersection ID: 45644	Main Street: W_5TH_ST	Cross Street: W_6TH_ST	Location: SW
ADA ID: E735A56042CD	Ramp Type: PerpDiag	Initial Pass/Fail: Fail	Overall Compliance: No
			Severity Score: 21.25

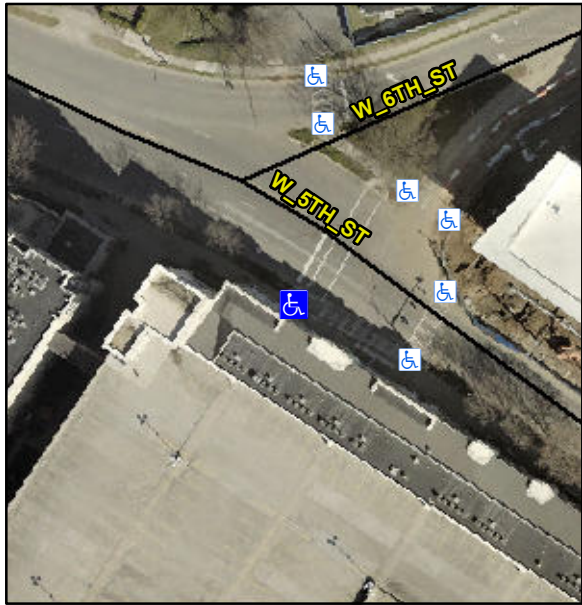
Possible Solutions:		Compliance	Description	Data	Compliance	Description	Data
	Remove & Replace Curb Ramp With Two New Directional Ramps or Equivalent.		N/A	Ramp Length (in)	70.0	Yes	Ramp Slope (%)	5.9
			No	Ramp Width (in)	41.0	No	Ramp XSlope (%)	6.7
			N/A	Flare Type LT	N/A	N/A	Flare Type RT	N/A
			N/A	Flare Slope LT (%)	N/A	N/A	Flare Slope RT (%)	N/A
			N/A	Flare Traversable LT?	N/A	N/A	Flare Traversable RT?	N/A
			N/A	Landing Length (in)	N/A	N/A	DWS Provided?	N/A
			N/A	Landing Width (in)	N/A	N/A	DWS Contrast?	N/A
			N/A	Landing Slope (%)	N/A	N/A	DWS Length (in)	N/A
			N/A	Landing X Slope (%)	N/A	N/A	DWS Full Width?	N/A
Surveyor Notes:		N/A	N/A	Landing Curb? (Y/N)	N/A	N/A	DWS Offset (in)	N/A
PROW/ADA:		Not Found, R304.5.1, R304.5.3	N/A	Shared Landing?	N/A			
			N/A	Gutter Ponding?	N/A	N/A	Gutter Slope (%)	N/A
