# Access Compliance Report

## Public Rights-of-Way

### (Curb Ramps)

Intersection ID: 16646	Main Street: ORCHARD_CR	Cross Street: S_TRYON_ST	Location: W
ADA ID: E737062E20E9	Ramp Type: PerpDiag	Initial Pass/Fail: Fail	Overall Compliance: No
		Severity Score: 8.75

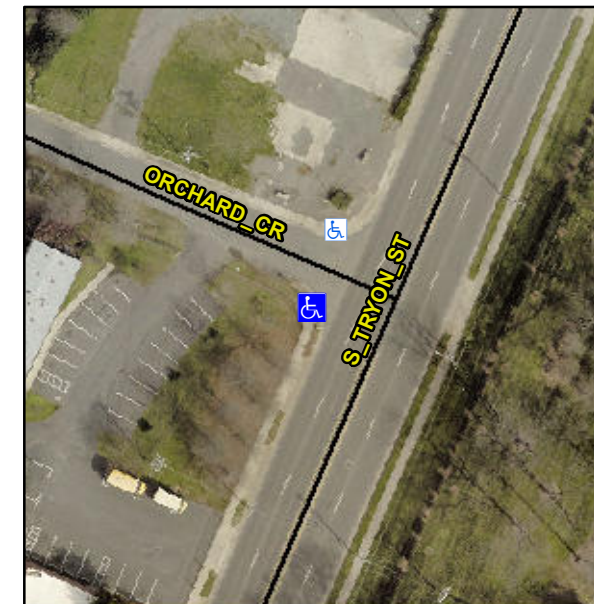
Compliance	Description	Data	Compliance	Description	Data
N/A	Ramp Length (in)	114.0	Yes	Ramp Slope (%)	7.3
No	Ramp Width (in)	38.0	Yes	Ramp XSlope (%)	1.5
N/A	Flare Type LT	N/A	N/A	Flare Type RT	N/A
N/A	Flare Slope LT (%)	N/A	N/A	Flare Slope RT (%)	N/A
N/A	Flare Traversable LT?	N/A	N/A	Flare Traversable RT?	N/A
N/A	Landing Length (in)	N/A	N/A	DWS Provided?	N/A
N/A	Landing Width (in)	N/A	N/A	DWS Contrast?	N/A
N/A	Landing Slope (%)	N/A	N/A	DWS Length (in)	N/A
N/A	Landing X Slope (%)	N/A	N/A	DWS Full Width?	N/A
N/A	Landing Curb? (Y/N)	N/A	N/A	DWS Offset (in)	N/A
N/A	Shared Landing?	N/A			
N/A	Gutter Ponding?	N/A	N/A	Gutter Slope (%)	N/A
N/A	Gutter Lip Ht (in)	1.0	N/A	Gutter X Slope (%)	N/A
N/A	Painted X Walk1?	No	N/A	Painted X Walk2?	No
	X Walk 1 Direction	To SE		X Walk 2 Direction	To NE
N/A	X Walk 1 Width (in)	N/A	N/A	X Walk 2 Width (in)	N/A
	X Walk 1 Slope (%)	0.7		X Walk 2 Slope (%)	1.0
	X Walk 1 X Slope (%)	1.6		X Walk 2 X Slope (%)	1.4

N/A	Ramp inside XWalk1?	N/A	N/A	Ramp inside XWalk2?	N/A
	Road Slope (%)	2.1	N/A	Clear Space?	N/A
	Road X Slope (%)	1.1	N/A	Clear Space to XWalk (in)	N/A
N/A	Any Obstructions?	N/A	N/A	Storm Grate/Utility Hazard?	N/A
	Obstruction Type			Storm Grate/Utility Type	
		N/A			N/A
			Yes	Surface Condition? (G/P)	Good

**Remove & Replace Curb Ramp With Two New Directional Ramps or Equivalent.**

**R304.5.1**

Total Cost: \$ 3200.00
