Access Compliance Report

Public Rights-of-Way

(Curb Ramps)

| Intersection ID: 13234 | Main Street: ABBEYDALE_DR | Cross Street: N_SHARON_AMITY_RD | Location: | E |

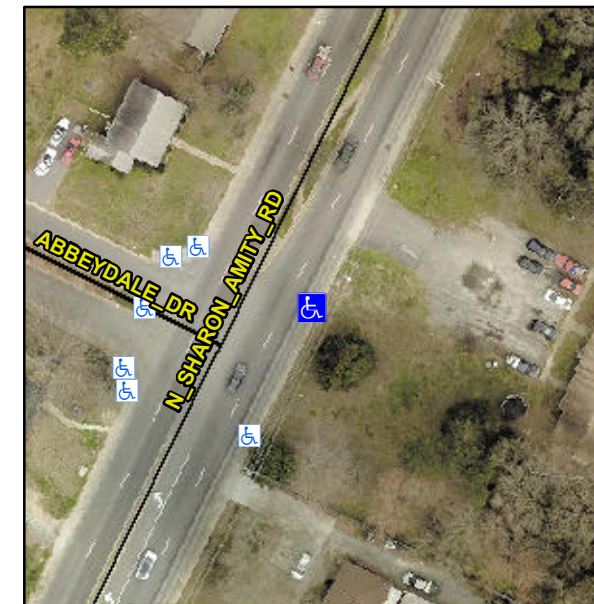
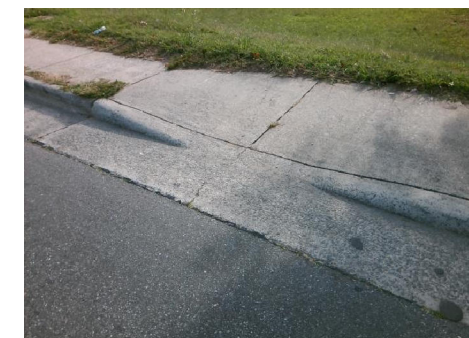
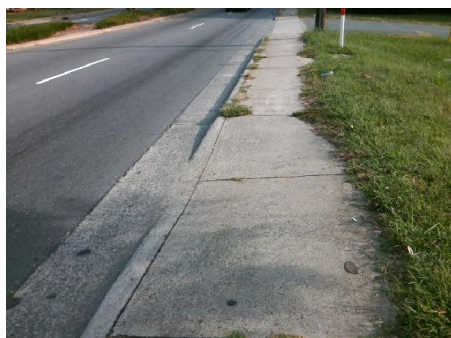
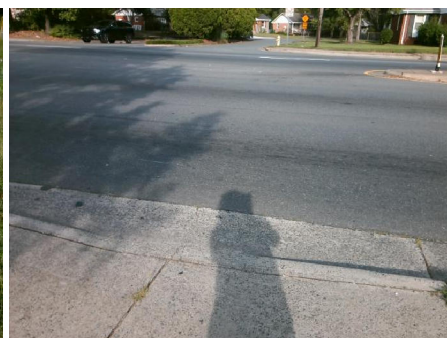
| ADA ID: E7479045AD76 | Ramp Type: Perp | Initial Pass/Fail: Fail | Overall Compliance: No | Severity Score: 22.5 |

Not Found, R304.5.1, R304.2.2, R304.5.3

| Compliance | Description | Data | Compliance | Description | Data |
|---|---|---|---|---|---|
| N/A | Ramp Length (in) | 60.0 | No | Ramp Slope (%) | 9.0 |
| No | Ramp Width (in) | 44.0 | No | Ramp XSlope (%) | 3.7 |

Remove & Replace Entire Ramp.
