Access Compliance Report

Public Rights-of-Way

(Curb Ramps)

Intersection ID: 45164	Main Street: ELESSAR_PL	Cross Street: ARAGORN_LN	Location: E
ADA ID: E747CF0BAEEF	Ramp Type: PerpDiag	Initial Pass/Fail: Fail	Overall Compliance: No
Severity Score: 8.75			
Codes/Mitigation Info/Possible Solution		Field Measurements/Component Compliance

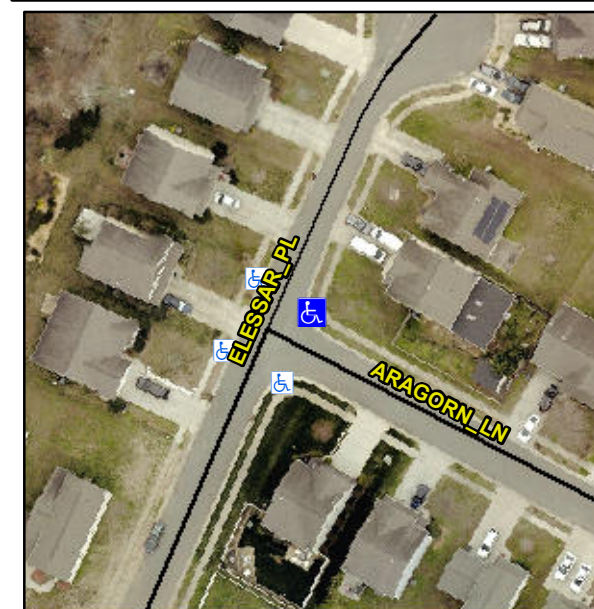
Not Found, R304.5.1

Compliance	Description	Data	Compliance	Description	Data
N/A	Ramp Length (in)	48.0	Yes	Ramp Slope (%)	7.3
No	Ramp Width (in)	43.0	Yes	Ramp XSlope (%)	0.9
N/A	Flare Type LT	N/A	N/A	Flare Type RT	N/A
N/A	Flare Slope LT (%)	N/A	N/A	Flare Slope RT (%)	N/A
N/A	Flare Traversable LT?	N/A	N/A	Flare Traversable RT?	N/A
N/A	Landing Length (in)	N/A	N/A	DWS Provided?	N/A
N/A	Landing Width (in)	N/A	N/A	DWS Contrast?	N/A
N/A	Landing Slope (%)	N/A	N/A	DWS Length (in)	N/A
N/A	Landing X Slope (%)	N/A	N/A	DWS Full Width?	N/A
N/A	Landing Curb? (Y/N)	N/A	N/A	DWS Offset (in)	N/A
N/A	Shared Landing?	N/A			
N/A	Gutter Ponding?	N/A	N/A	Gutter Slope (%)	N/A
N/A	Gutter Lip Ht (in)	N/A	N/A	Gutter X Slope (%)	N/A
N/A	Painted X Walk1?	No	N/A	Painted X Walk2?	No
	X Walk 1 Direction	To NW		X Walk 2 Direction	To SW
N/A	X Walk 1 Width (in)	N/A	N/A	X Walk 2 Width (in)	N/A
	X Walk 1 Slope (%)	2.8		X Walk 2 Slope (%)	3.2
	X Walk 1 X Slope (%)	3.9		X Walk 2 X Slope (%)	5.8

N/A	Ramp inside XWalk1?	N/A	N/A	Ramp inside XWalk2?	N/A
	Road Slope (%)	0.3	N/A	Clear Space?	N/A
	Road X Slope (%)	8.8	N/A	Clear Space to XWalk (in)	N/A
N/A	Any Obstructions?	N/A	N/A	Storm Grate/Utility Hazard?	N/A
	Obstruction Type			Storm Grate/Utility Type	
		N/A			N/A
		Yes		Surface Condition? (G/P)	Good

Remove & Replace Curb Ramp With Two New Directional Ramps or Equivalent.
