# Access Compliance Report

## Public Rights-of-Way

| Intersection ID: 29156 | Main Street: BRANSCOMB_DR | Cross Street: BRIDGEVILLE_LN | Location: SE |
| ADA ID: E74BFD395C5C | Ramp Type: PerpDiag | Initial Pass/Fail: Pass | Overall Compliance: No |

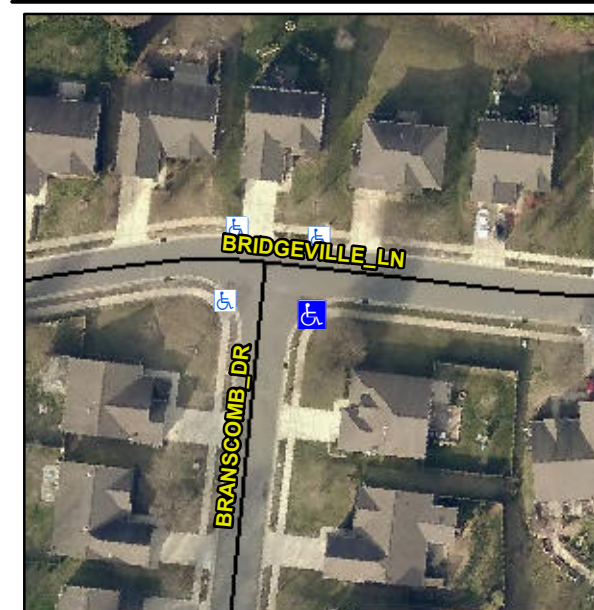
**Not Found, R304.5.3, R304.2.1, R305, R302.7.2**

| Compliance | Description | Data | Compliance | Description | Data |
|---|---|---|---|---|---|
| N/A | Ramp Length (in) | 48.0 | Yes | Ramp Slope (%) | 5.1 |
| Yes | Ramp Width (in) | 70.0 | No | Ramp XSlope (%) | 2.4 |
| No | Landing Length (in) | 47.0 | No | DWS Provided? | No |
| No | Landing X Slope (%) | 3.4 | N/A | DWS Full Width? | No |
| No | Gutter Lip Ht (in) | 0.5 | No | Gutter X Slope (%) | 3.1 |

**Remove & Replace Curb Ramp With Two New Directional Ramps or Equivalent. Remove & Replace Gutter.**
