# Access Compliance Report

## Public Rights-of-Way

### (Curb Ramps)

Intersection ID: 48147	Main Street: MCCAMEY_DR	Cross Street: FRANKLIN_MEADOWS_DR	Location: SE
ADA ID: E7603FC8BA7E	Ramp Type: Perp	Initial Pass/Fail: Fail	Overall Compliance: No
			Severity Score: 21.25

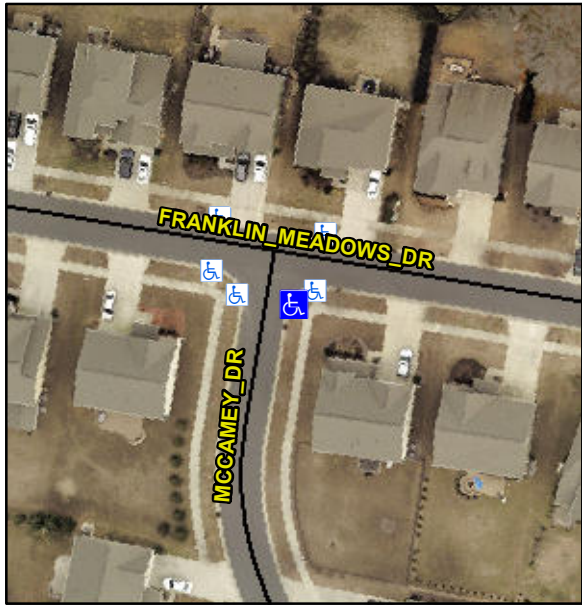
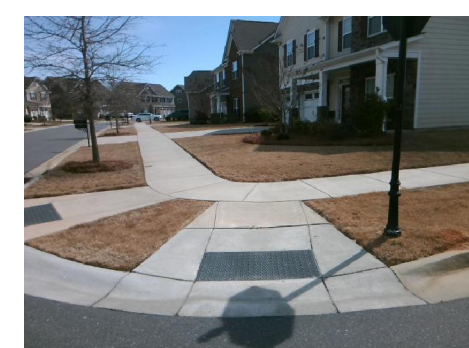
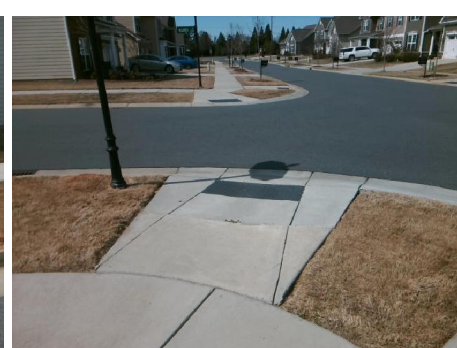
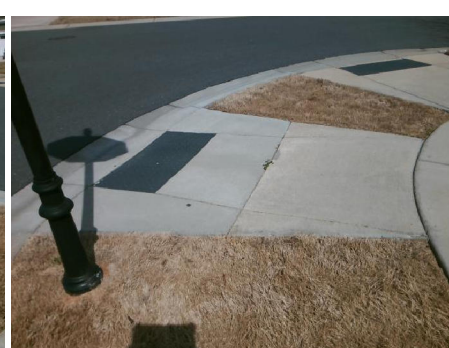
Possible Solutions:		Compliance	Description	Data	Compliance	Description	Data
	Remove & Replace Entire Ramp.		N/A	Ramp Length (in)	98.0	No	Ramp Slope (%)	9.0
			No	Ramp Width (in)	47.0	Yes	Ramp XSlope (%)	0.1
			N/A	Flare Type LT	N/A	N/A	Flare Type RT	N/A
			N/A	Flare Slope LT (%)	N/A	N/A	Flare Slope RT (%)	N/A
			N/A	Flare Traversable LT?	N/A	N/A	Flare Traversable RT?	N/A
			N/A	Landing Length (in)	N/A	N/A	DWS Provided?	N/A
			N/A	Landing Width (in)	N/A	N/A	DWS Contrast?	N/A
			N/A	Landing Slope (%)	N/A	N/A	DWS Length (in)	N/A
			N/A	Landing X Slope (%)	N/A	N/A	DWS Full Width?	N/A
Surveyor Notes:		N/A	N/A	Landing Curb? (Y/N)	N/A	N/A	DWS Offset (in)	N/A
PROW/ADA:		Not Found, R304.5.1, R304.2.2	N/A	Shared Landing?	N/A	N/A	Gutter Slope (%)	N/A
			N/A	Gutter Ponding?	N/A	N/A	Gutter X Slope (%)	N/A
			N/A	Gutter Lip Ht (in)	N/A	N/A	Painted X Walk2?	N/A

N/A	Painted X Walk1?	No	N/A	X Walk 2 Direction	N/A
				X Walk 1 Direction	To W		X Walk 2 Width (in)	N/A
			N/A	X Walk 1 Width (in)	N/A	N/A	X Walk 2 Slope (%)	N/A
				X Walk 1 Slope (%)	1.5		X Walk 2 X Slope (%)	N/A
				X Walk 1 X Slope (%)	1.6		Ramp inside XWalk2?	N/A
			N/A	Ramp inside XWalk1?	N/A	N/A	Clear Space?	N/A
				Road Slope (%)	N/A	N/A	Clear Space to XWalk (in)	N/A
				Road X Slope (%)	N/A	N/A	Storm Grate/Utility Hazard?	N/A
			N/A	Any Obstructions?	N/A	N/A	Storm Grate/Utility Type	N/A
				Obstruction Type				
					N/A			N/A
						Yes	Surface Condition? (G/P)	Good
