# Access Compliance Report

## Public Rights-of-Way

### (Curb Ramps)

Intersection ID: N/A	Main Street: HAMILTON_BRIDGE_RD	Cross Street: DALLAS_BAY_RD	Location: SE
ADA ID: E7721AF5A9F2	Ramp Type: Perp	Initial Pass/Fail: Fail	Overall Compliance: No
Severity Score: 12.5			
Codes/Mitigation Info/Possible Solution		Field Measurements/Component Compliance

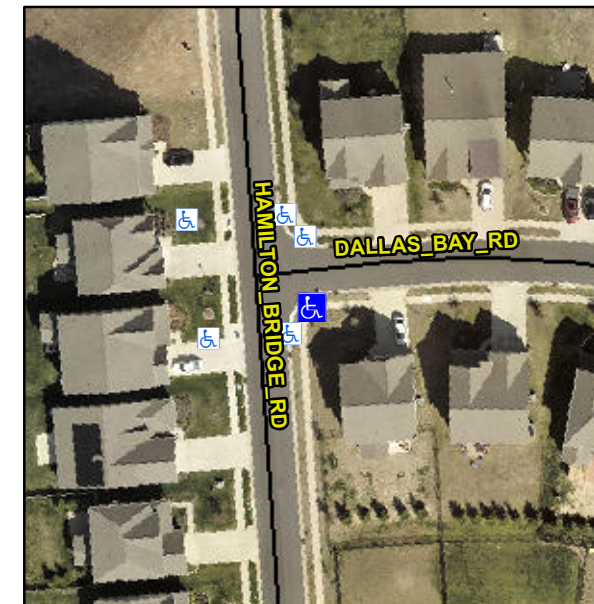
Compliance	Description	Data	Compliance	Description	Data
N/A	Ramp Length (in)	50.0	No	Ramp Slope (%)	11.7
Yes	Ramp Width (in)	48.0	Yes	Ramp XSlope (%)	1.6
N/A	Flare Type LT	N/A	N/A	Flare Type RT	N/A
N/A	Flare Slope LT (%)	N/A	N/A	Flare Slope RT (%)	N/A
N/A	Flare Traversable LT?	N/A	N/A	Flare Traversable RT?	N/A
N/A	Landing Length (in)	N/A	N/A	DWS Provided?	N/A
N/A	Landing Width (in)	N/A	N/A	DWS Contrast?	N/A
N/A	Landing Slope (%)	N/A	N/A	DWS Length (in)	N/A
N/A	Landing X Slope (%)	N/A	N/A	DWS Full Width?	N/A
N/A	Landing Curb? (Y/N)	N/A	N/A	DWS Offset (in)	N/A
N/A	Shared Landing?	N/A			
N/A	Gutter Ponding?	N/A	N/A	Gutter Slope (%)	N/A
N/A	Gutter Lip Ht (in)	2.0	N/A	Gutter X Slope (%)	N/A
N/A	Painted X Walk1?	No	N/A	Painted X Walk2?	N/A
	X Walk 1 Direction	To N		X Walk 2 Direction	N/A
N/A	X Walk 1 Width (in)	N/A	N/A	X Walk 2 Width (in)	N/A
	X Walk 1 Slope (%)	2.3		X Walk 2 Slope (%)	N/A
	X Walk 1 X Slope (%)	0.5		X Walk 2 X Slope (%)	N/A

N/A	Ramp inside XWalk1?	N/A	N/A	Ramp inside XWalk2?	N/A
	Road Slope (%)	N/A	N/A	Clear Space?	N/A
	Road X Slope (%)	N/A	N/A	Clear Space to XWalk (in)	N/A
N/A	Any Obstructions?	N/A	N/A	Storm Grate/Utility Hazard?	N/A
	Obstruction Type			Storm Grate/Utility Type	
		N/A			N/A
		Yes		Surface Condition? (G/P)	Good

Possible Solutions:

**Remove & Replace Entire Ramp.**

**Not Found, R304.2.2**
