Access Compliance Report

Public Rights-of-Way

(Curb Ramps)

Intersection ID: 10029691	Main Street: KINGSLEY_VIEW_DR	Cross Street: N/A	Location: SE
ADA ID: E77DC097C9F0	Ramp Type: BlendTrans1	Initial Pass/Fail: Fail	Overall Compliance: No
Severity Score: 36.25			
Codes/Mitigation Info/Possible Solution		Field Measurements/Component Compliance

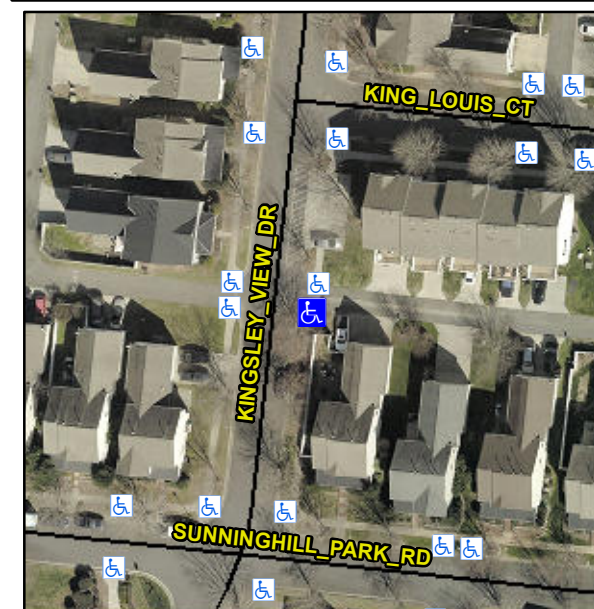
Not Found, R304.5.1

Compliance	Description	Data	Compliance	Description	Data
N/A	Ramp Length (in)	77.0	Yes	BlendTrans Slope (%)	3.4
No	Ramp Width (in)	25.0	Yes	BlendTrans XSlope (%)	2.6
N/A	Flare Type LT	N/A	N/A	Flare Type RT	N/A
N/A	Flare Slope LT (%)	N/A	N/A	Flare Slope RT (%)	N/A
N/A	Flare Traversable LT?	N/A	N/A	Flare Traversable RT?	N/A
N/A	Landing Length (in)	N/A	N/A	DWS Provided?	N/A
N/A	Landing Width (in)	N/A	N/A	DWS Contrast?	N/A
N/A	Landing Slope (%)	N/A	N/A	DWS Length (in)	N/A
N/A	Landing X Slope (%)	N/A	N/A	DWS Full Width?	N/A
N/A	Landing Curb? (Y/N)	N/A	N/A	DWS Offset (in)	N/A
N/A	Shared Landing?	N/A			
N/A	Gutter Ponding?	N/A	N/A	Gutter Slope (%)	N/A
N/A	Gutter Lip Ht (in)	N/A	N/A	Gutter X Slope (%)	N/A
N/A	Painted X Walk1?	No	N/A	Painted X Walk2?	No
	X Walk 1 Direction	To N		X Walk 2 Direction	To W
	X Walk 1 Width (in)	N/A		X Walk 2 Width (in)	N/A
	X Walk 1 Slope (%)	1.1		X Walk 2 Slope (%)	2.2
	X Walk 1 X Slope (%)	0.5		X Walk 2 X Slope (%)	3.4

N/A	Ramp inside XWalk1?	N/A	N/A	Ramp inside XWalk2?	N/A
	Road Slope (%)	3.1		Clear Space?	N/A
	Road X Slope (%)	0.5	N/A	Clear Space to XWalk (in)	N/A
N/A	Any Obstructions?	N/A	N/A	Storm Grate/Utility Hazard?	N/A
	Obstruction Type			Storm Grate/Utility Type	
		N/A			N/A
			Yes	Surface Condition? (G/P)	Good
			No	Curb Slope (%)	12.1

Remove & Replace Curb Ramp With Two New Directional Ramps or Equivalent.

Total Cost: \$ 3200.00
