# Access Compliance Report

## Public Rights-of-Way

### (Curb Ramps)

Intersection ID: 48166	Main Street: NORTHLAKE_MALL_DR	Cross Street: NORTHLAKE_CENTRE_PY	Location: SE
ADA ID: E7800904FEC9	Ramp Type: Perp	Initial Pass/Fail: Fail	Overall Compliance: No
Severity Score: 33.75			
Codes/Mitigation Info/Possible Solution		Field Measurements/Component Compliance

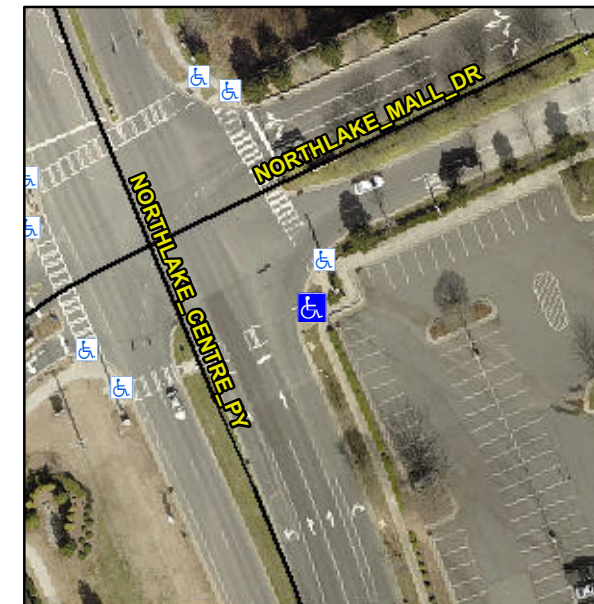
**Not Found, R304.5.1, R304.2.2, R304.5.3**

Compliance	Description	Data	Compliance	Description	Data
N/A	Ramp Length (in)	94.0	No	Ramp Slope (%)	9.5
No	Ramp Width (in)	45.5	No	Ramp XSlope (%)	5.1
N/A	Flare Type LT	N/A	N/A	Flare Type RT	N/A
N/A	Flare Slope LT (%)	N/A	N/A	Flare Slope RT (%)	N/A
N/A	Flare Traversable LT?	N/A	N/A	Flare Traversable RT?	N/A
N/A	Landing Length (in)	N/A	N/A	DWS Provided?	N/A
N/A	Landing Width (in)	N/A	N/A	DWS Contrast?	N/A
N/A	Landing Slope (%)	N/A	N/A	DWS Length (in)	N/A
N/A	Landing X Slope (%)	N/A	N/A	DWS Full Width?	N/A
N/A	Landing Curb? (Y/N)	N/A	N/A	DWS Offset (in)	N/A
N/A	Shared Landing?	N/A			
N/A	Gutter Ponding?	N/A	N/A	Gutter Slope (%)	N/A
N/A	Gutter Lip Ht (in)	N/A	N/A	Gutter X Slope (%)	N/A
N/A	Painted X Walk1?	Yes	N/A	Painted X Walk2?	N/A
	X Walk 1 Direction	To SW		X Walk 2 Direction	N/A
N/A	X Walk 1 Width (in)	110.0	N/A	X Walk 2 Width (in)	N/A
	X Walk 1 Slope (%)	2.5		X Walk 2 Slope (%)	N/A
	X Walk 1 X Slope (%)	5.8		X Walk 2 X Slope (%)	N/A

N/A	Ramp inside XWalk1?	Yes	N/A	Ramp inside XWalk2?	N/A
	Road Slope (%)	N/A	N/A	Clear Space?	N/A
	Road X Slope (%)	N/A	N/A	Clear Space to XWalk (in)	N/A
N/A	Any Obstructions?	N/A	N/A	Storm Grate/Utility Hazard?	N/A
	Obstruction Type			Storm Grate/Utility Type	
		N/A			N/A
			Yes	Surface Condition? (G/P)	Good

**Remove & Replace Entire Ramp.**
