Access Compliance Report

Public Rights-of-Way

(Curb Ramps)

Intersection ID: N/A	Main Street: E_INDEPENDENCE_BV	Cross Street: N/A	Location: W
ADA ID: E7812BFC3105	Ramp Type: IslandPara	Initial Pass/Fail: Fail	Overall Compliance: No
Codes/Mitigation Info/Possible Solution		Field Measurements/Component Compliance	
Severity Score: 22.5

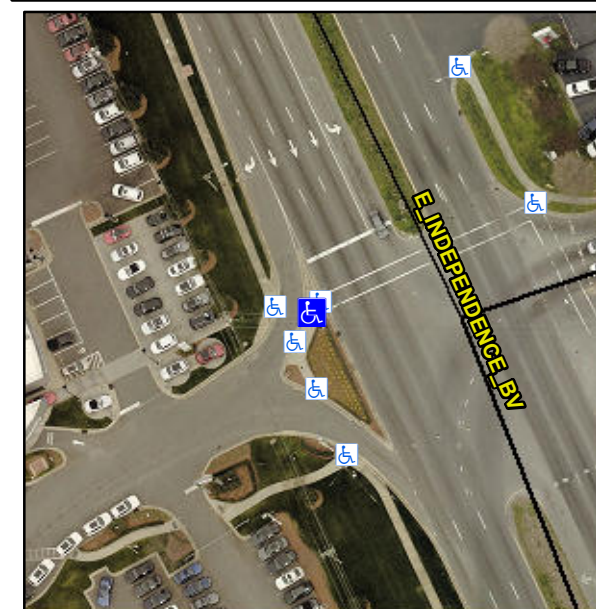
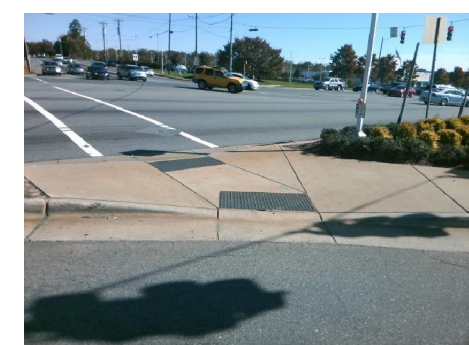
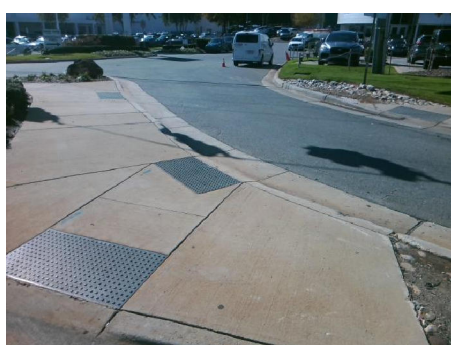
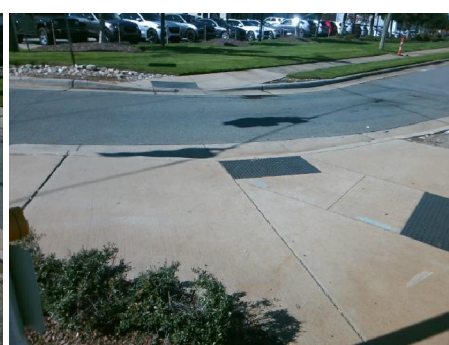
R304.5.1, R304.3.2, R304.5.3

Compliance	Description	Data	Compliance	Description	Data
N/A	Ramp Length LT (in)	79.0	N/A	Ramp Length RT (in)	72.0
No	Ramp Width LT (in)	38.5	Yes	Ramp Width RT (in)	80.0
No	Ramp Slope LT (%)	9.0	Yes	Ramp Slope RT (%)	6.1
No	Ramp XSlope LT (%)	4.0	No	Ramp XSlope RT (%)	2.2
N/A	Landing Length (in)	N/A	N/A	DWS Provided?	N/A
N/A	Landing Width (in)	N/A	N/A	DWS Contrast?	N/A
N/A	Landing Slope (%)	N/A	N/A	DWS Length (in)	N/A
N/A	Landing X Slope (%)	N/A	N/A	DWS Full Width?	N/A
N/A	Landing Curb? (Y/N)	N/A	N/A	DWS Offset (in)	N/A
N/A	Shared Landing?	N/A			
N/A	Gutter Ponding?	N/A	N/A	Gutter Slope (%)	N/A
N/A	Gutter Lip Ht (in)	N/A	N/A	Gutter X Slope (%)	N/A
N/A	Painted X Walk1?	No	N/A	Painted X Walk2?	N/A
	X Walk 1 Direction	To W		X Walk 2 Direction	N/A
N/A	X Walk 1 Width (in)	N/A	N/A	X Walk 2 Width (in)	N/A
	X Walk 1 Slope (%)	3.4		X Walk 2 Slope (%)	N/A
	X Walk 1 X Slope (%)	1.8		X Walk 2 X Slope (%)	N/A
N/A	Ramp inside XWalk1?	N/A	N/A	Ramp inside XWalk2?	N/A

Road Slope (%)	N/A	N/A	Clear Space?	N/A
	Road X Slope (%)	N/A	N/A	Clear Space to XWalk (in)	N/A
N/A	Any Obstructions?	N/A	N/A	Storm Grate/Utility Hazard?	N/A
	Obstruction Type			Storm Grate/Utility Type	
		N/A			N/A
			Yes	Surface Condition? (G/P)	Good
			N/A	Curb Slope (%)	15.8

Remove & Replace Entire Ramp.

Total Cost: \$ 3400.00
