Access Compliance Report

Public Rights-of-Way

(Curb Ramps)

Intersection ID: 10093	Main Street: MILTON_RD	Cross Street: THE_PLAZA	Location: SW
ADA ID: E7887CE5A0E9	Ramp Type: Perp	Initial Pass/Fail: Fail	Overall Compliance: No
Severity Score: 21.25			
Codes/Mitigation Info/Possible Solution		Field Measurements/Component Compliance

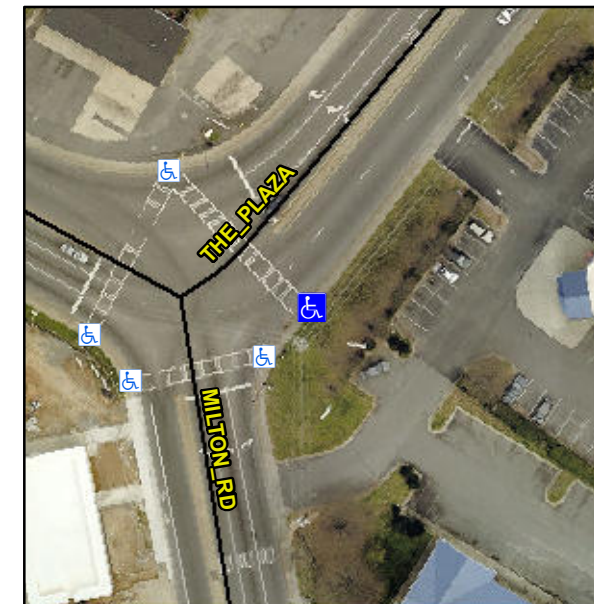
Not Found, R304.5.1, R304.2.2

Compliance	Description	Data	Compliance	Description	Data
N/A	Ramp Length (in)	60.0	No	Ramp Slope (%)	10.9
No	Ramp Width (in)	43.0	Yes	Ramp XSlope (%)	1.4
N/A	Flare Type LT	N/A	N/A	Flare Type RT	N/A
N/A	Flare Slope LT (%)	N/A	N/A	Flare Slope RT (%)	N/A
N/A	Flare Traversable LT?	N/A	N/A	Flare Traversable RT?	N/A
N/A	Landing Length (in)	N/A	N/A	DWS Provided?	N/A
N/A	Landing Width (in)	N/A	N/A	DWS Contrast?	N/A
N/A	Landing Slope (%)	N/A	N/A	DWS Length (in)	N/A
N/A	Landing X Slope (%)	N/A	N/A	DWS Full Width?	N/A
N/A	Landing Curb? (Y/N)	N/A	N/A	DWS Offset (in)	N/A
N/A	Shared Landing?	N/A			
N/A	Gutter Ponding?	N/A	N/A	Gutter Slope (%)	N/A
N/A	Gutter Lip Ht (in)	N/A	N/A	Gutter X Slope (%)	N/A
N/A	Painted X Walk1?	Yes	N/A	Painted X Walk2?	N/A
	X Walk 1 Direction	To NW		X Walk 2 Direction	N/A
N/A	X Walk 1 Width (in)	109.5	N/A	X Walk 2 Width (in)	N/A
	X Walk 1 Slope (%)	2.7		X Walk 2 Slope (%)	N/A
	X Walk 1 X Slope (%)	0.8		X Walk 2 X Slope (%)	N/A

N/A	Ramp inside XWalk1?	Yes	N/A	Ramp inside XWalk2?	N/A
	Road Slope (%)	N/A	N/A	Clear Space?	N/A
	Road X Slope (%)	N/A	N/A	Clear Space to XWalk (in)	N/A
N/A	Any Obstructions?	N/A	N/A	Storm Grate/Utility Hazard?	N/A
	Obstruction Type			Storm Grate/Utility Type	
		N/A			N/A
			Yes	Surface Condition? (G/P)	Good

Possible Solutions:

Remove & Replace Entire Ramp.
