# Access Compliance Report

## Public Rights-of-Way

### (Curb Ramps)

Intersection ID: 51701	Main Street: STEELECROFT_PY	Cross Street: HOOVER_CREEK_BV	Location: SE
ADA ID: E78A4F4F2C60	Ramp Type: Perp	Initial Pass/Fail: Fail	Overall Compliance: No
Severity Score: 12.5			
Codes/Mitigation Info/Possible Solution		Field Measurements/Component Compliance

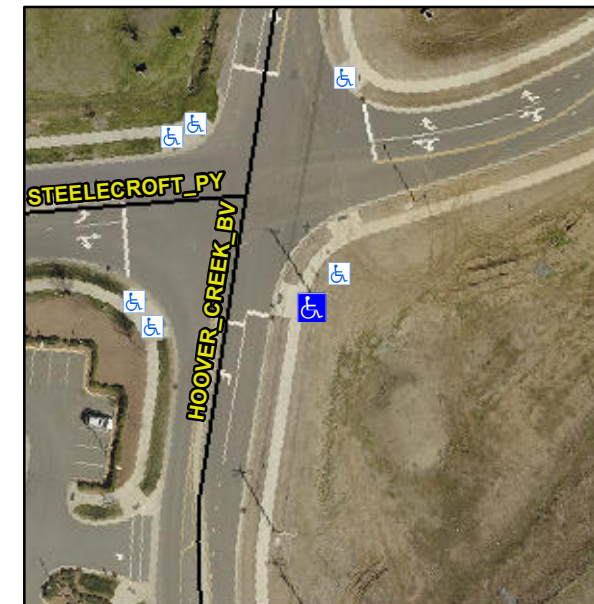
**Not Found, R304.2.2**

Compliance	Description	Data	Compliance	Description	Data
N/A	Ramp Length (in)	93.0	No	Ramp Slope (%)	8.6
Yes	Ramp Width (in)	67.0	Yes	Ramp XSlope (%)	1.4
N/A	Flare Type LT	N/A	N/A	Flare Type RT	N/A
N/A	Flare Slope LT (%)	N/A	N/A	Flare Slope RT (%)	N/A
N/A	Flare Traversable LT?	N/A	N/A	Flare Traversable RT?	N/A
N/A	Landing Length (in)	N/A	N/A	DWS Provided?	N/A
N/A	Landing Width (in)	N/A	N/A	DWS Contrast?	N/A
N/A	Landing Slope (%)	N/A	N/A	DWS Length (in)	N/A
N/A	Landing X Slope (%)	N/A	N/A	DWS Full Width?	N/A
N/A	Landing Curb? (Y/N)	N/A	N/A	DWS Offset (in)	N/A
N/A	Shared Landing?	N/A			
N/A	Gutter Ponding?	N/A	N/A	Gutter Slope (%)	N/A
N/A	Gutter Lip Ht (in)	N/A	N/A	Gutter X Slope (%)	N/A
N/A	Painted X Walk1?	No	N/A	Painted X Walk2?	N/A
	X Walk 1 Direction	To SW		X Walk 2 Direction	N/A
N/A	X Walk 1 Width (in)	N/A	N/A	X Walk 2 Width (in)	N/A
	X Walk 1 Slope (%)	3.3		X Walk 2 Slope (%)	N/A
	X Walk 1 X Slope (%)	3.2		X Walk 2 X Slope (%)	N/A

N/A	Ramp inside XWalk1?	N/A	N/A	Ramp inside XWalk2?	N/A
	Road Slope (%)	N/A	N/A	Clear Space?	N/A
	Road X Slope (%)	N/A	N/A	Clear Space to XWalk (in)	N/A
N/A	Any Obstructions?	N/A	N/A	Storm Grate/Utility Hazard?	N/A
	Obstruction Type			Storm Grate/Utility Type	
		N/A			N/A
			Yes	Surface Condition? (G/P)	Good

**Remove & Replace Entire Ramp.**

Total Cost: \$ 1850.00
