Access Compliance Report

Public Rights-of-Way

(Curb Ramps)

Intersection ID: 12998	Main Street: E_5TH_ST	Cross Street: N_MCDOWELL_ST	Location:	N
ADA ID: E79B805CD448	Ramp Type: Perp	Initial Pass/Fail: Fail	Overall Compliance: No	Severity Score: 25

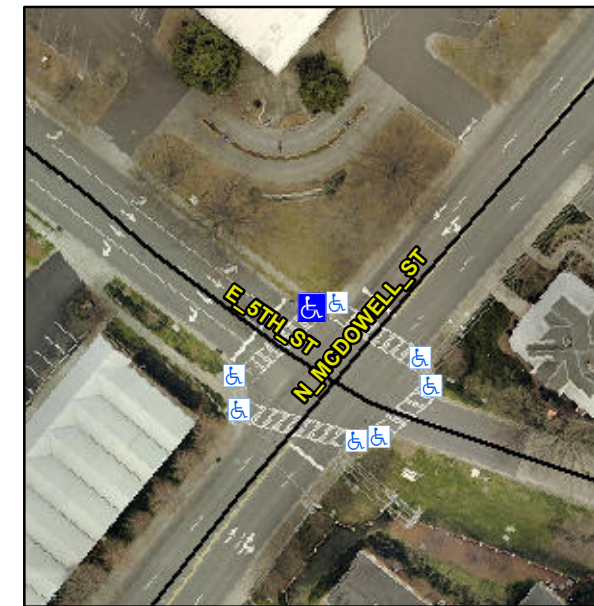
Not Found, R304.2.2, R304.5.3

Compliance	Description	Data	Compliance	Description	Data
N/A	Ramp Length (in)	84.0	No	Ramp Slope (%)	8.8
Yes	Ramp Width (in)	54.0	No	Ramp XSlope (%)	5.8
N/A	Flare Type LT	N/A	N/A	Flare Type RT	N/A
N/A	Flare Slope LT (%)	N/A	N/A	Flare Slope RT (%)	N/A
N/A	Flare Traversable LT?	N/A	N/A	Flare Traversable RT?	N/A
N/A	Landing Length (in)	N/A	N/A	DWS Provided?	N/A
N/A	Landing Width (in)	N/A	N/A	DWS Contrast?	N/A
N/A	Landing Slope (%)	N/A	N/A	DWS Length (in)	N/A
N/A	Landing X Slope (%)	N/A	N/A	DWS Full Width?	N/A
N/A	Landing Curb? (Y/N)	N/A	N/A	DWS Offset (in)	N/A
N/A	Shared Landing?	N/A			
N/A	Gutter Ponding?	N/A	N/A	Gutter Slope (%)	N/A
N/A	Gutter Lip Ht (in)	N/A	N/A	Gutter X Slope (%)	N/A
N/A	Painted X Walk1?	Yes	N/A	Painted X Walk2?	N/A
	X Walk 1 Direction	To SW		X Walk 2 Direction	N/A
N/A	X Walk 1 Width (in)	93.0	N/A	X Walk 2 Width (in)	N/A
	X Walk 1 Slope (%)	5.0		X Walk 2 Slope (%)	N/A
	X Walk 1 X Slope (%)	3.9		X Walk 2 X Slope (%)	N/A

N/A	Ramp inside XWalk1?	Yes	N/A	Ramp inside XWalk2?	N/A
	Road Slope (%)	N/A	N/A	Clear Space?	N/A
	Road X Slope (%)	N/A	N/A	Clear Space to XWalk (in)	N/A
N/A	Any Obstructions?	N/A	N/A	Storm Grate/Utility Hazard?	N/A
	Obstruction Type			Storm Grate/Utility Type	
		N/A			N/A
		Yes		Surface Condition? (G/P)	Good

Remove & Replace Entire Ramp.

Total Cost: \$ 1850.00
