Access Compliance Report

Public Rights-of-Way

(Curb Ramps)

Intersection ID: 52790	Main Street: COLEMON_KERRY_DR	Cross Street: FRIENDSHIP_VILLAGE_PL	Location: SW
ADA ID: E7A5199389B2	Ramp Type: Perp	Initial Pass/Fail: Fail	Overall Compliance: No
Severity Score: 21.25			
Codes/Mitigation Info/Possible Solution		Field Measurements/Component Compliance

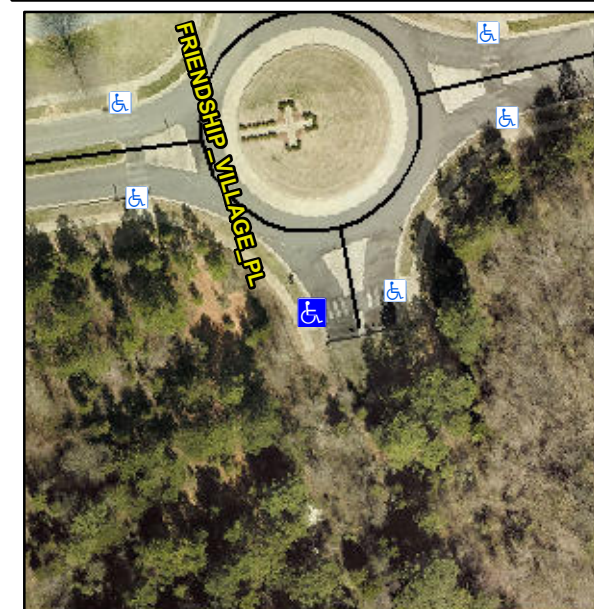
Not Found, R304.5.1, R304.2.2

Compliance	Description	Data	Compliance	Description	Data
N/A	Ramp Length (in)	73.5	No	Ramp Slope (%)	8.6
No	Ramp Width (in)	47.0	Yes	Ramp XSlope (%)	0.1
N/A	Flare Type LT	N/A	N/A	Flare Type RT	N/A
N/A	Flare Slope LT (%)	N/A	N/A	Flare Slope RT (%)	N/A
N/A	Flare Traversable LT?	N/A	N/A	Flare Traversable RT?	N/A
N/A	Landing Length (in)	N/A	N/A	DWS Provided?	N/A
N/A	Landing Width (in)	N/A	N/A	DWS Contrast?	N/A
N/A	Landing Slope (%)	N/A	N/A	DWS Length (in)	N/A
N/A	Landing X Slope (%)	N/A	N/A	DWS Full Width?	N/A
N/A	Landing Curb? (Y/N)	N/A	N/A	DWS Offset (in)	N/A
N/A	Shared Landing?	N/A			
N/A	Gutter Ponding?	N/A	N/A	Gutter Slope (%)	N/A
N/A	Gutter Lip Ht (in)	N/A	N/A	Gutter X Slope (%)	N/A
N/A	Painted X Walk1?	No	N/A	Painted X Walk2?	N/A
	X Walk 1 Direction	To E		X Walk 2 Direction	N/A
N/A	X Walk 1 Width (in)	N/A	N/A	X Walk 2 Width (in)	N/A
	X Walk 1 Slope (%)	3.1		X Walk 2 Slope (%)	N/A
	X Walk 1 X Slope (%)	1.0		X Walk 2 X Slope (%)	N/A

N/A	Ramp inside XWalk1?	N/A	N/A	Ramp inside XWalk2?	N/A
	Road Slope (%)	N/A	N/A	Clear Space?	N/A
	Road X Slope (%)	N/A	N/A	Clear Space to XWalk (in)	N/A
N/A	Any Obstructions?	N/A	N/A	Storm Grate/Utility Hazard?	N/A
	Obstruction Type			Storm Grate/Utility Type	
		N/A			N/A
			Yes	Surface Condition? (G/P)	Good

Possible Solutions:

Remove & Replace Entire Ramp.

Total Cost: \$ 1850.00
