Access Compliance Report

Public Rights-of-Way

(Curb Ramps)

Intersection ID: 10021978	Main Street: BROOKSVALE_ST	Cross Street: N/A	Location: SE
ADA ID: E7AD4A2EBB2	Ramp Type: Perp	Initial Pass/Fail: Fail	Overall Compliance: No
Severity Score: 13.75			
Codes/Mitigation Info/Possible Solution		Field Measurements/Component Compliance

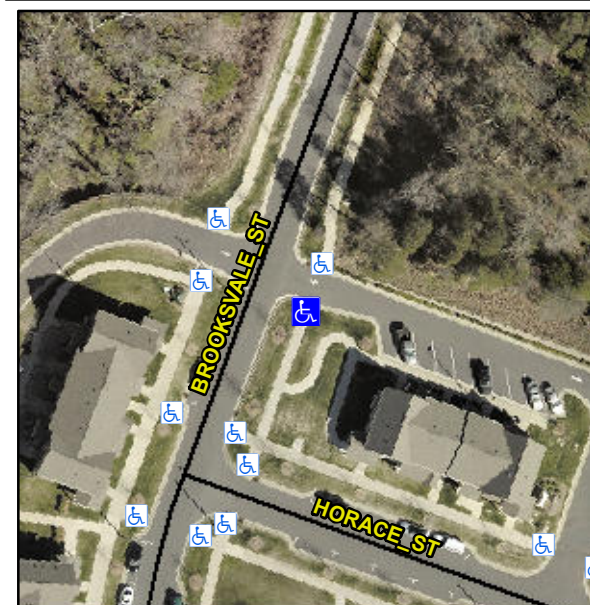
Not Found, R304.2.2

Compliance	Description	Data	Compliance	Description	Data
N/A	Ramp Length (in)	67.0	No	Ramp Slope (%)	10.1
Yes	Ramp Width (in)	71.0	Yes	Ramp XSlope (%)	2.4
N/A	Flare Type LT	N/A	N/A	Flare Type RT	N/A
N/A	Flare Slope LT (%)	N/A	N/A	Flare Slope RT (%)	N/A
N/A	Flare Traversable LT?	N/A	N/A	Flare Traversable RT?	N/A
N/A	Landing Length (in)	N/A	N/A	DWS Provided?	N/A
N/A	Landing Width (in)	N/A	N/A	DWS Contrast?	N/A
N/A	Landing Slope (%)	N/A	N/A	DWS Length (in)	N/A
N/A	Landing X Slope (%)	N/A	N/A	DWS Full Width?	N/A
N/A	Landing Curb? (Y/N)	N/A	N/A	DWS Offset (in)	N/A
N/A	Shared Landing?	N/A			
N/A	Gutter Ponding?	N/A	N/A	Gutter Slope (%)	N/A
N/A	Gutter Lip Ht (in)	N/A	N/A	Gutter X Slope (%)	N/A
N/A	Painted X Walk1?	No	N/A	Painted X Walk2?	N/A
	X Walk 1 Direction	To NE		X Walk 2 Direction	N/A
N/A	X Walk 1 Width (in)	N/A	N/A	X Walk 2 Width (in)	N/A
	X Walk 1 Slope (%)	1.9		X Walk 2 Slope (%)	N/A
	X Walk 1 X Slope (%)	4.3		X Walk 2 X Slope (%)	N/A

Remove & Replace Entire Ramp.

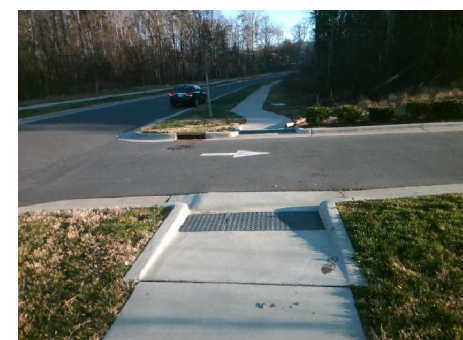
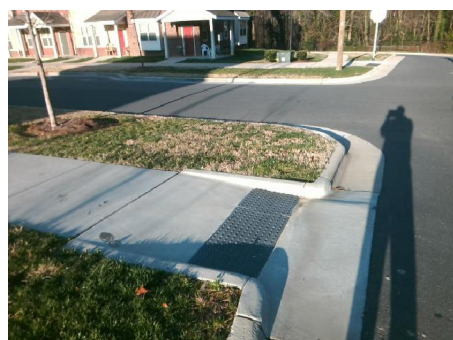
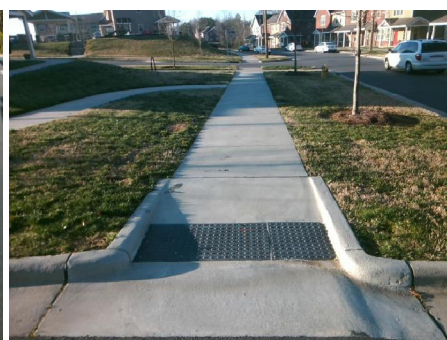
N/A	Ramp inside XWalk1?	N/A	N/A	Ramp inside XWalk2?	N/A
	Road Slope (%)	N/A	N/A	Clear Space?	N/A
	Road X Slope (%)	N/A	N/A	Clear Space to XWalk (in)	N/A
N/A	Any Obstructions?	N/A	N/A	Storm Grate/Utility Hazard?	N/A
	Obstruction Type			Storm Grate/Utility Type	
		N/A			N/A
			Yes	Surface Condition? (G/P)	Good
