Access Compliance Report

Public Rights-of-Way

(Curb Ramps)

Intersection ID: 52336	Main Street: WOODWARD_AV	Cross Street: KOHLER_AV	Location:	N
ADA ID: E7AF0CC2803B	Ramp Type: Perp	Initial Pass/Fail: Pass	Overall Compliance: No	Severity Score: 0
Codes/Mitigation Info/Possible Solution		Field Measurements/Component Compliance

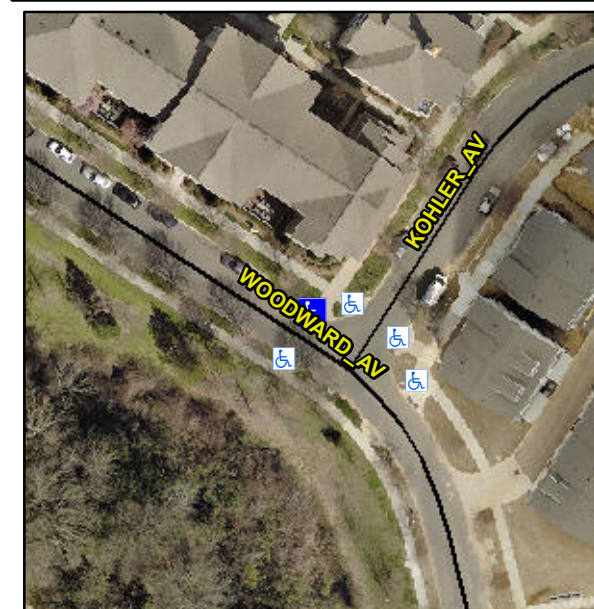
Not Found, R305.1.4, R305.2, R302.7

Compliance	Description	Data	Compliance	Description	Data
N/A	Ramp Length (in)	73.0	Yes	Ramp Slope (%)	5.9
Yes	Ramp Width (in)	95.0	Yes	Ramp XSlope (%)	0.3
N/A	Flare Type LT	Sloped	N/A	Flare Type RT	N/A
N/A	Flare Slope LT (%)	8.7	N/A	Flare Slope RT (%)	6.6
N/A	Flare Traversable LT?	No	N/A	Flare Traversable RT?	No
Yes	Landing Length (in)	93.0	Yes	DWS Provided?	Yes
Yes	Landing Width (in)	96.0	Yes	DWS Contrast?	Yes
Yes	Landing Slope (%)	0.9	No	DWS Length (in)	23.5
Yes	Landing X Slope (%)	1.4	Yes	DWS Full Width?	Yes
N/A	Landing Curb? (Y/N)	No	No	DWS Offset (in)	4.5
N/A	Shared Landing?	No			
No	Gutter Ponding?	Yes	Yes	Gutter Slope (%)	2.7
Yes	Gutter Lip Ht (in)	0.0	Yes	Gutter X Slope (%)	0.7
N/A	Painted X Walk1?	No	N/A	Painted X Walk2?	N/A
	X Walk 1 Direction	To SW		X Walk 2 Direction	N/A
N/A	X Walk 1 Width (in)	N/A	N/A	X Walk 2 Width (in)	N/A
	X Walk 1 Slope (%)	1.2		X Walk 2 Slope (%)	N/A
	X Walk 1 X Slope (%)	1.4		X Walk 2 X Slope (%)	N/A

N/A	Ramp inside XWalk1?	N/A	N/A	Ramp inside XWalk2?	N/A
	Road Slope (%)	N/A	N/A	Clear Space?	Yes
	Road X Slope (%)	N/A	N/A	Clear Space to XWalk (in)	N/A
Yes	Any Obstructions?	No	Yes	Storm Grate/Utility Hazard?	No
	Obstruction Type			Storm Grate/Utility Type	
		N/A			N/A
			Yes	Surface Condition? (G/P)	Good

Remove & Replace Entire Ramp.
