Access Compliance Report

Public Rights-of-Way

(Curb Ramps)

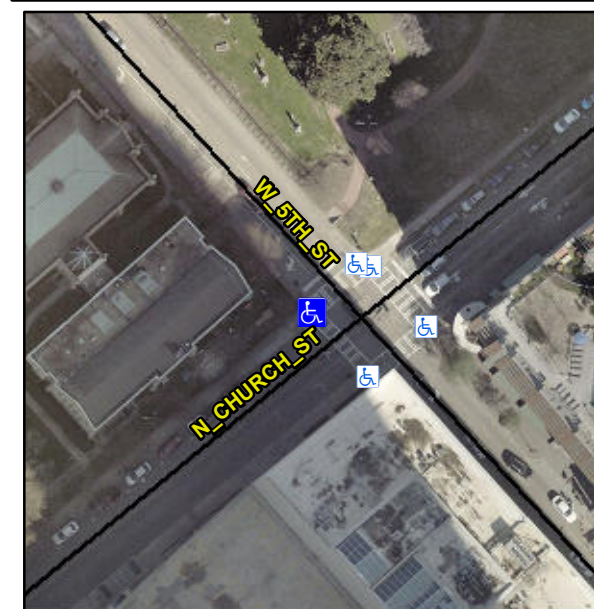
Intersection ID: 12076	Main Street: N_CHURCH_ST	Cross Street: W_5TH_ST	Location: W
ADA ID: E7CD235B7DAB	Ramp Type: Directional2	Initial Pass/Fail: Fail	Overall Compliance: No
Severity Score: 41.25			
Codes/Mitigation Info/Possible Solution		Field Measurements/Component Compliance

Compliance	Description	Data	Compliance	Description	Data
N/A	Ramp Length (in)	57.0	N/A	Grade Break?	N/A
Yes	Ramp Width (in)	48.0	N/A	Grade Break Slope (%)	0.0
No	Ramp Slope (%)	18.5	N/A	Grade Break XSlope (%)	0.0
No	Ramp XSlope (%)	2.7			
N/A	Flare Type LT	N/A	N/A	Flare Type RT	N/A
N/A	Flare Slope LT (%)	N/A	N/A	Flare Slope RT (%)	0.0
N/A	Flare Traversable LT?	N/A	N/A	Flare Traversable RT?	N/A
N/A	Landing Length (in)	0.0	N/A	DWS Provided?	N/A
N/A	Landing Width (in)	0.0	N/A	DWS Contrast?	N/A
N/A	Landing Slope (%)	0.0	N/A	DWS Length (in)	N/A
N/A	Landing X Slope (%)	0.0	N/A	DWS Full Width?	N/A
N/A	Landing Curb? (Y/N)	N/A	N/A	DWS Offset LT (in)	N/A
N/A	Shared Landing?	N/A	N/A	DWS Offset RT (in)	N/A
N/A	Gutter Ponding?	0.0	N/A	Gutter Slope (%)	N/A
N/A	Gutter Lip Ht (in)	0.0	N/A	Gutter X Slope (%)	N/A
N/A	Painted X Walk1?	Yes		Road Slope (%)	1.4
	X Walk 1 Direction	To NE		Road X Slope (%)	2.1
	X Walk 1 Width (in)	110.0		Clear Space?	N/A

X Walk 1 Slope (%)	1.4	N/A	Clear Space to XWalk (in)	N/A
	X Walk 1 X Slope (%)	2.1	N/A	Storm Grate/Utility Hazard?	N/A
N/A	Ramp inside XWalk1?	Yes		Storm Grate/Utility Type	
N/A	Any Obstructions?	N/A			N/A
	Obstruction Type		No	Surface Condition? (G/P)	Poor
			N/A	Curb Slope (%)	8.4

Possible Solutions:

Remove & Replace Entire Ramp.
