# Access Compliance Report

## Public Rights-of-Way

### (Curb Ramps)

Intersection ID: 9547	Main Street: GENESIS_PARK_PL	Cross Street: PEACEFUL_WAY_DR	Location: W
ADA ID: E7D50902D877	Ramp Type: Perp	Initial Pass/Fail: Fail	Overall Compliance: No
Severity Score: 12.5			
Codes/Mitigation Info/Possible Solution		Field Measurements/Component Compliance

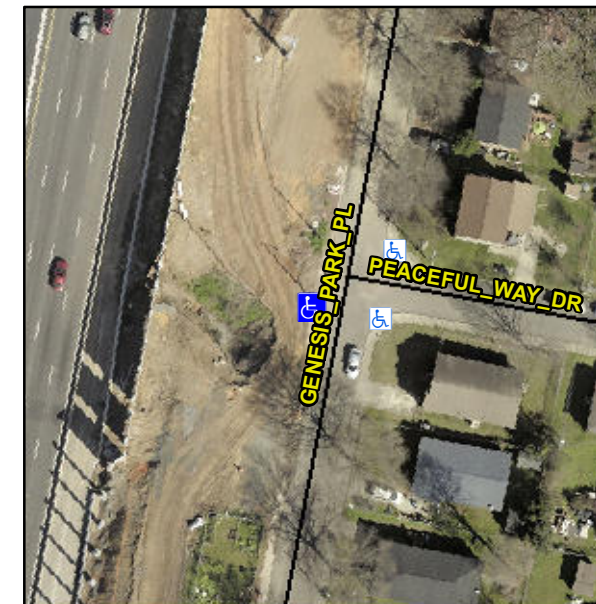
Compliance	Description	Data	Compliance	Description	Data
N/A	Ramp Length (in)	32.0	No	Ramp Slope (%)	9.9
Yes	Ramp Width (in)	49.0	Yes	Ramp XSlope (%)	0.6
N/A	Flare Type LT	N/A	N/A	Flare Type RT	N/A
N/A	Flare Slope LT (%)	N/A	N/A	Flare Slope RT (%)	N/A
N/A	Flare Traversable LT?	N/A	N/A	Flare Traversable RT?	N/A
N/A	Landing Length (in)	N/A	N/A	DWS Provided?	N/A
N/A	Landing Width (in)	N/A	N/A	DWS Contrast?	N/A
N/A	Landing Slope (%)	N/A	N/A	DWS Length (in)	N/A
N/A	Landing X Slope (%)	N/A	N/A	DWS Full Width?	N/A
N/A	Landing Curb? (Y/N)	N/A	N/A	DWS Offset (in)	N/A
N/A	Shared Landing?	N/A			
N/A	Gutter Ponding?	N/A	N/A	Gutter Slope (%)	N/A
N/A	Gutter Lip Ht (in)	1.5	N/A	Gutter X Slope (%)	N/A
N/A	Painted X Walk1?	No	N/A	Painted X Walk2?	N/A
	X Walk 1 Direction	To SE		X Walk 2 Direction	N/A
N/A	X Walk 1 Width (in)	N/A	N/A	X Walk 2 Width (in)	N/A
	X Walk 1 Slope (%)	3.9		X Walk 2 Slope (%)	N/A
	X Walk 1 X Slope (%)	0.5		X Walk 2 X Slope (%)	N/A

N/A	Ramp inside XWalk1?	N/A	N/A	Ramp inside XWalk2?	N/A
	Road Slope (%)	N/A	N/A	Clear Space?	N/A
	Road X Slope (%)	N/A	N/A	Clear Space to XWalk (in)	N/A
N/A	Any Obstructions?	N/A	N/A	Storm Grate/Utility Hazard?	N/A
	Obstruction Type			Storm Grate/Utility Type	
		N/A			N/A
			Yes	Surface Condition? (G/P)	Good

Possible Solutions:

**Remove & Replace Entire Ramp.**

**R304.2.2**

**\$ 1850.00**
