Access Compliance Report

Public Rights-of-Way

(Curb Ramps)

Intersection ID: N/A	Main Street: ALLEGIANCE DR	Cross Street: LADY LIBERTY LN	Location: NE
ADA ID: E7E2C9A21FFE	Ramp Type: PerpDiag	Initial Pass/Fail: Fail	Overall Compliance: No
		Severity Score: 10

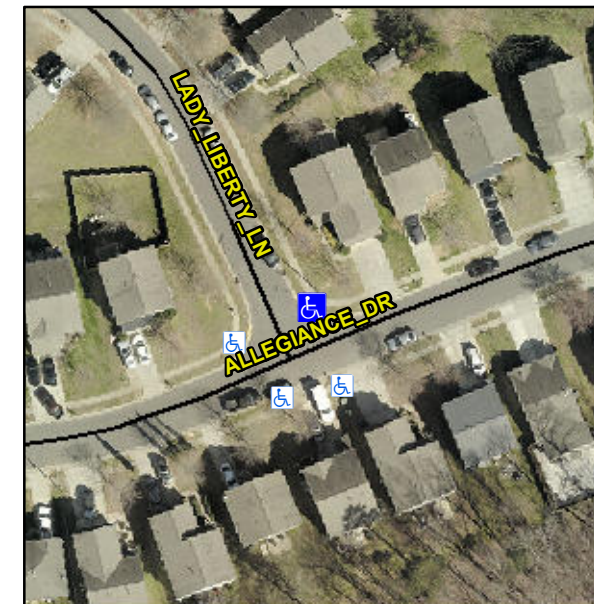
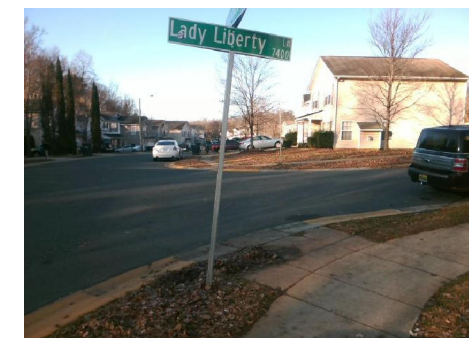
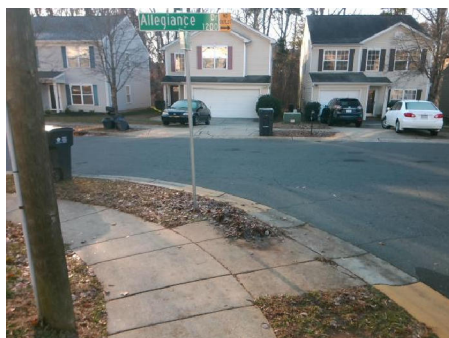
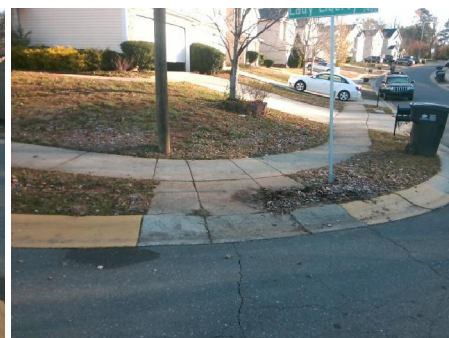
Not Found, R304.5.1, R304.5.3

Compliance	Description	Data	Compliance	Description	Data
N/A	Ramp Length (in)	49.0	Yes	Ramp Slope (%)	6.9
No	Ramp Width (in)	38.0	No	Ramp XSlope (%)	3.7
N/A	Flare Type LT	N/A	N/A	Flare Type RT	N/A
N/A	Flare Slope LT (%)	N/A	N/A	Flare Slope RT (%)	N/A
N/A	Flare Traversable LT?	No	N/A	Flare Traversable RT?	No
N/A	Landing Length (in)	N/A	N/A	DWS Provided?	N/A
N/A	Landing Width (in)	N/A	N/A	DWS Contrast?	N/A
N/A	Landing Slope (%)	N/A	N/A	DWS Length (in)	N/A
N/A	Landing X Slope (%)	N/A	N/A	DWS Full Width?	N/A
N/A	Landing Curb? (Y/N)	N/A	N/A	DWS Offset (in)	N/A
N/A	Shared Landing?	N/A			
N/A	Gutter Ponding?	N/A	N/A	Gutter Slope (%)	N/A
N/A	Gutter Lip Ht (in)	N/A	N/A	Gutter X Slope (%)	N/A
N/A	Painted X Walk1?	No	N/A	Painted X Walk2?	No
	X Walk 1 Direction	To W		X Walk 2 Direction	To S
N/A	X Walk 1 Width (in)	N/A	N/A	X Walk 2 Width (in)	N/A
	X Walk 1 Slope (%)	5.0		X Walk 2 Slope (%)	0.3
	X Walk 1 X Slope (%)	1.4		X Walk 2 X Slope (%)	4.0

N/A	Ramp inside XWalk1?	No	N/A	Ramp inside XWalk2?	No
	Road Slope (%)	3.8	N/A	Clear Space?	N/A
	Road X Slope (%)	2.1	N/A	Clear Space to XWalk (in)	N/A
N/A	Any Obstructions?	N/A	N/A	Storm Grate/Utility Hazard?	N/A
	Obstruction Type			Storm Grate/Utility Type	
		N/A			N/A
			Yes	Surface Condition? (G/P)	Good

Remove & Replace Curb Ramp With Two New Directional Ramps or Equivalent.

Total Cost: \$ 3200.00
