Access Compliance Report

Public Rights-of-Way

(Curb Ramps)

Intersection ID: 12354	Main Street: ELDRIDGE_ST	Cross Street: MORRIS_ST	Location: NW
ADA ID: E7E937E47023	Ramp Type: ParaDiag	Initial Pass/Fail: Pass	Overall Compliance: No
		Severity Score: 4

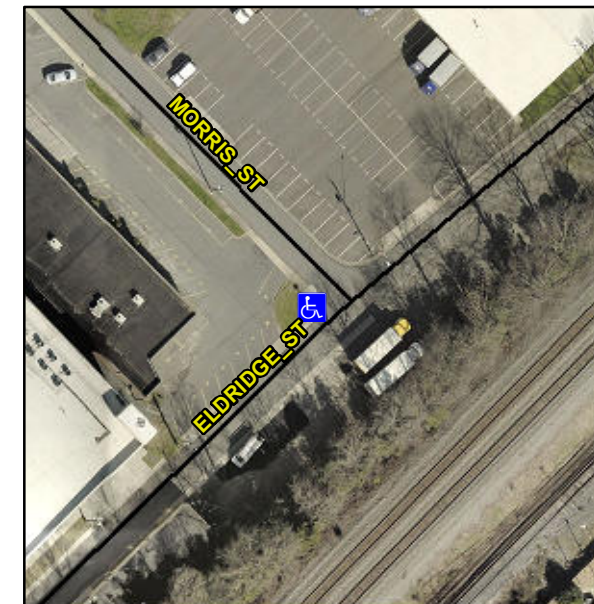
Compliance	Description	Data	Compliance	Description	Data
N/A	Ramp Length LT (in)	52.0	N/A	Ramp Length RT (in)	50.0
Yes	Ramp Width LT (in)	48.0	Yes	Ramp Width RT (in)	48.0
Yes	Ramp Slope LT (%)	7.2	Yes	Ramp Slope RT (%)	5.4
Yes	Ramp XSlope LT (%)	1.3	Yes	Ramp XSlope RT (%)	1.4
No	Landing Length (in)	45.0	Yes	DWS Provided?	Yes
No	Landing Width (in)	37.0	Yes	DWS Contrast?	Yes
No	Landing Slope (%)	3.6	Yes	DWS Length (in)	24.0
No	Landing X Slope (%)	4.9	Yes	DWS Full Width?	Yes
N/A	Landing Curb? (Y/N)	No	Yes	DWS Offset (in)	2.0
N/A	Shared Landing?	No			
Yes	Gutter Ponding?	No	Yes	Gutter Slope (%)	1.7
Yes	Gutter Lip Ht (in)	0.0	No	Gutter X Slope (%)	2.4
N/A	Painted X Walk1?	No	N/A	Painted X Walk2?	No
	X Walk 1 Direction	To S		X Walk 2 Direction	To E
N/A	X Walk 1 Width (in)	N/A	N/A	X Walk 2 Width (in)	N/A
	X Walk 1 Slope (%)	6.4		X Walk 2 Slope (%)	3.5
	X Walk 1 X Slope (%)	2.7		X Walk 2 X Slope (%)	1.0
N/A	Ramp inside XWalk1?	N/A	N/A	Ramp inside XWalk2?	N/A

Road Slope (%)	2.1	N/A	Clear Space?	Yes
	Road X Slope (%)	4.5	N/A	Clear Space to XWalk (in)	N/A
Yes	Any Obstructions?	No	Yes	Storm Grate/Utility Hazard?	No
	Obstruction Type			Storm Grate/Utility Type	
		N/A			N/A
			Yes	Surface Condition? (G/P)	Good
			Compliant	Curb Slope (%)	2.5

Possible Solutions:

**Remove & Replace Landing.
Remove & Replace Gutter.**
