# Access Compliance Report

## Public Rights-of-Way (Curb Ramps)

Intersection ID: 22920	Main Street: HAMILTON_MILL_RD	Cross Street: PROVIDENCE_RD	Location: SE
ADA ID: E7F482E54148	Ramp Type: Perp	Initial Pass/Fail: Fail	Overall Compliance: No
Severity Score: 46.25			
Codes/Mitigation Info/Possible Solution		Field Measurements/Component Compliance

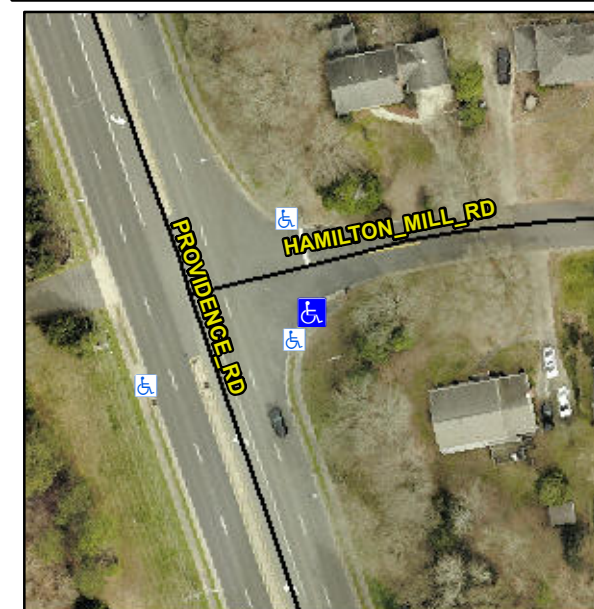
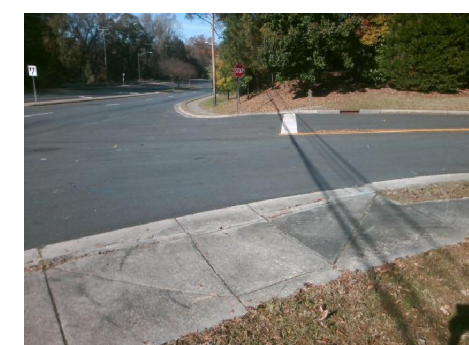
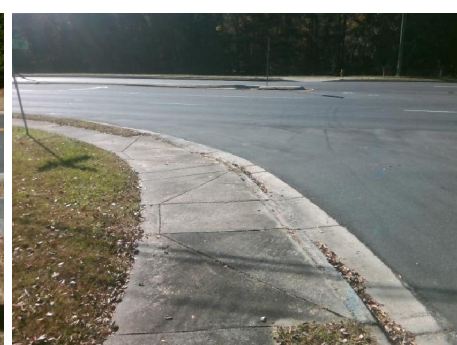
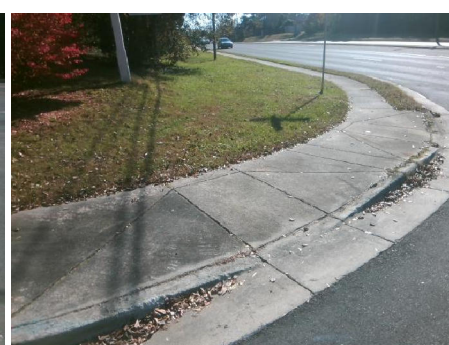
**Not Found, R304.5.1, R304.2.2, R304.5.3**

Compliance	Description	Data	Compliance	Description	Data
N/A	Ramp Length (in)	72.0	No	Ramp Slope (%)	12.7
No	Ramp Width (in)	42.0	No	Ramp XSlope (%)	6.4
N/A	Flare Type LT	N/A	N/A	Flare Type RT	N/A
N/A	Flare Slope LT (%)	N/A	N/A	Flare Slope RT (%)	N/A
N/A	Flare Traversable LT?	N/A	N/A	Flare Traversable RT?	N/A
N/A	Landing Length (in)	N/A	N/A	DWS Provided?	N/A
N/A	Landing Width (in)	N/A	N/A	DWS Contrast?	N/A
N/A	Landing Slope (%)	N/A	N/A	DWS Length (in)	N/A
N/A	Landing X Slope (%)	N/A	N/A	DWS Full Width?	N/A
N/A	Landing Curb? (Y/N)	N/A	N/A	DWS Offset (in)	N/A
N/A	Shared Landing?	N/A			
N/A	Gutter Ponding?	N/A	N/A	Gutter Slope (%)	N/A
N/A	Gutter Lip Ht (in)	N/A	N/A	Gutter X Slope (%)	N/A
N/A	Painted X Walk1?	No	N/A	Painted X Walk2?	N/A
	X Walk 1 Direction	To N		X Walk 2 Direction	N/A
N/A	X Walk 1 Width (in)	N/A	N/A	X Walk 2 Width (in)	N/A
	X Walk 1 Slope (%)	2.0		X Walk 2 Slope (%)	N/A
	X Walk 1 X Slope (%)	6.3		X Walk 2 X Slope (%)	N/A

N/A	Ramp inside XWalk1?	N/A	N/A	Ramp inside XWalk2?	N/A
	Road Slope (%)	N/A	N/A	Clear Space?	N/A
	Road X Slope (%)	N/A	N/A	Clear Space to XWalk (in)	N/A
N/A	Any Obstructions?	N/A	N/A	Storm Grate/Utility Hazard?	N/A
	Obstruction Type			Storm Grate/Utility Type	
		N/A			N/A
			Yes	Surface Condition? (G/P)	Good

**Remove & Replace Entire Ramp.**

Total Cost: \$ 1850.00
