Access Compliance Report

Public Rights-of-Way (Curb Ramps)

Intersection ID: N/A	Main Street: 3RD_ST	Cross Street: JOHN_BELK_FY	Location: E
ADA ID: E7FC7D4ED055	Ramp Type: Directional1	Initial Pass/Fail: Pass	Overall Compliance: No
		Severity Score: 0.25

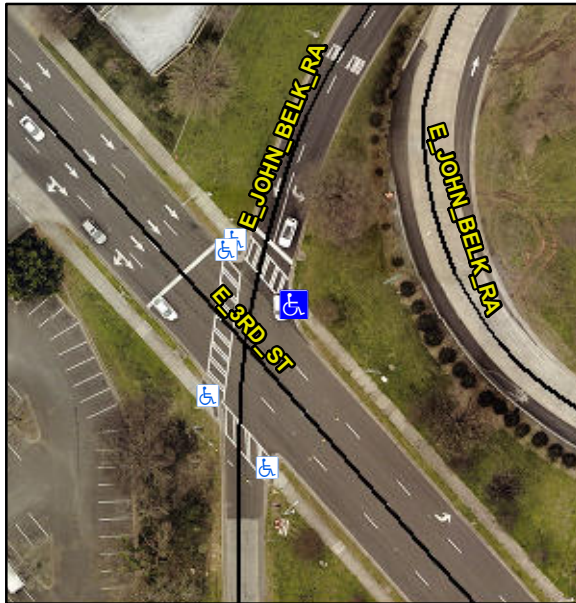
R304.5.3, R304.5.2

Compliance	Description	Data	Compliance	Description	Data
N/A	Ramp Length (in)	64.0	No	Grade Break?	No
Yes	Ramp Width (in)	84.0	N/A	Grade Break Slope (%)	N/A
Yes	Ramp Slope (%)	0.3	N/A	Grade Break XSlope (%)	N/A
No	Ramp XSlope (%)	3.4			
N/A	Flare Type LT	N/A	N/A	Flare Type RT	N/A
N/A	Flare Slope LT (%)	N/A	N/A	Flare Slope RT (%)	N/A
N/A	Flare Traversable LT?	N/A	N/A	Flare Traversable RT?	N/A
Yes	Landing Length (in)	60.0	Yes	DWS Provided?	Yes
Yes	Landing Width (in)	84.0	Yes	DWS Contrast?	Yes
Yes	Landing Slope (%)	1.7	Yes	DWS Length (in)	24.0
No	Landing X Slope (%)	2.9	Yes	DWS Full Width?	Yes
N/A	Landing Curb? (Y/N)	N/A	Yes	DWS Offset LT (in)	2.0
N/A	Shared Landing?	No	Yes	DWS Offset RT (in)	2.0
Yes	Gutter Ponding?	No	Yes	Gutter Slope (%)	0.1
Yes	Gutter Lip Ht (in)	0.0	Yes	Gutter X Slope (%)	0.9
N/A	Painted X Walk1?	Yes		Road Slope (%)	2.5
	X Walk 1 Direction	To NW		Road X Slope (%)	1.2
	X Walk 1 Width (in)	118.0		Clear Space?	Yes

X Walk 1 Slope (%)	2.5	N/A	Clear Space to XWalk (in)	N/A
	X Walk 1 X Slope (%)	1.2	Yes	Storm Grate/Utility Hazard?	No
Yes	Ramp inside XWalk1?	Yes		Storm Grate/Utility Type	
Yes	Any Obstructions?	No			N/A
	Obstruction Type		Yes	Surface Condition? (G/P)	Good
			N/A	Curb Slope (%)	6.4

Possible Solutions:

Remove & Replace Entire Ramp.

Total Cost: \$ **1600.00**
