# Access Compliance Report

## Public Rights-of-Way

### (Curb Ramps)

Intersection ID: N/A	Main Street: PAISLEY_ABBEY_LN	Cross Street: KELBURN_LN	Location: NE
ADA ID: E7FFC4639E28	Ramp Type: Perp	Initial Pass/Fail: Fail	Overall Compliance: No
		Severity Score: 8.75

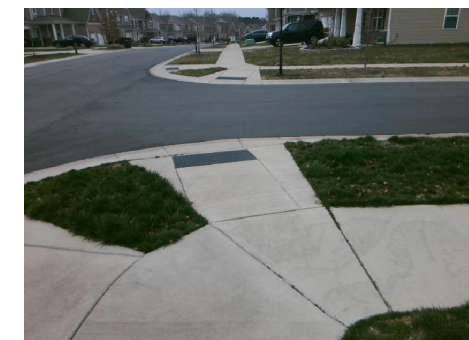
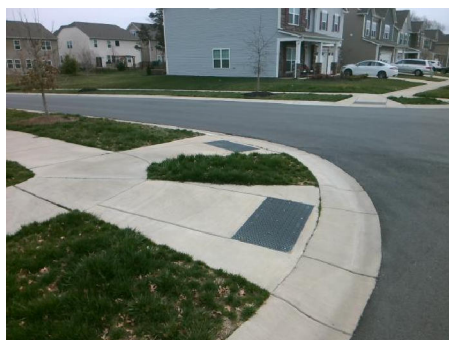
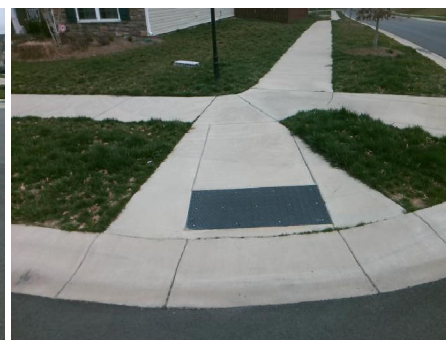
**Not Found, R304.5.1**

Compliance	Description	Data	Compliance	Description	Data
N/A	Ramp Length (in)	98.0	Yes	Ramp Slope (%)	5.4
No	Ramp Width (in)	38.0	Yes	Ramp XSlope (%)	1.4
N/A	Flare Type LT	N/A	N/A	Flare Type RT	N/A
N/A	Flare Slope LT (%)	N/A	N/A	Flare Slope RT (%)	N/A
N/A	Flare Traversable LT?	N/A	N/A	Flare Traversable RT?	N/A
N/A	Landing Length (in)	N/A	N/A	DWS Provided?	N/A
N/A	Landing Width (in)	N/A	N/A	DWS Contrast?	N/A
N/A	Landing Slope (%)	N/A	N/A	DWS Length (in)	N/A
N/A	Landing X Slope (%)	N/A	N/A	DWS Full Width?	N/A
N/A	Landing Curb? (Y/N)	N/A	N/A	DWS Offset (in)	N/A
N/A	Shared Landing?	N/A			
N/A	Gutter Ponding?	N/A	N/A	Gutter Slope (%)	N/A
N/A	Gutter Lip Ht (in)	N/A	N/A	Gutter X Slope (%)	N/A
N/A	Painted X Walk1?	No	N/A	Painted X Walk2?	N/A
	X Walk 1 Direction	To SW		X Walk 2 Direction	N/A
N/A	X Walk 1 Width (in)	N/A	N/A	X Walk 2 Width (in)	N/A
	X Walk 1 Slope (%)	0.8		X Walk 2 Slope (%)	N/A
	X Walk 1 X Slope (%)	1.9		X Walk 2 X Slope (%)	N/A

N/A	Ramp inside XWalk1?	N/A	N/A	Ramp inside XWalk2?	N/A
	Road Slope (%)	N/A	N/A	Clear Space?	N/A
	Road X Slope (%)	N/A	N/A	Clear Space to XWalk (in)	N/A
N/A	Any Obstructions?	N/A	N/A	Storm Grate/Utility Hazard?	N/A
	Obstruction Type			Storm Grate/Utility Type	
		N/A			N/A
			Yes	Surface Condition? (G/P)	Good

**Remove & Replace Entire Ramp.**

Total Cost: \$ 1850.00
