# Access Compliance Report

## Public Rights-of-Way

### (Curb Ramps)

Intersection ID: N/A	Main Street: COTTON PLANTER LN	Cross Street: ROCKY TRAIL CT	Location: NW
ADA ID: E8030CEBDBDA	Ramp Type: Perp	Initial Pass/Fail: Fail	Overall Compliance: No
Severity Score: 12.5			
Codes/Mitigation Info/Possible Solution		Field Measurements/Component Compliance

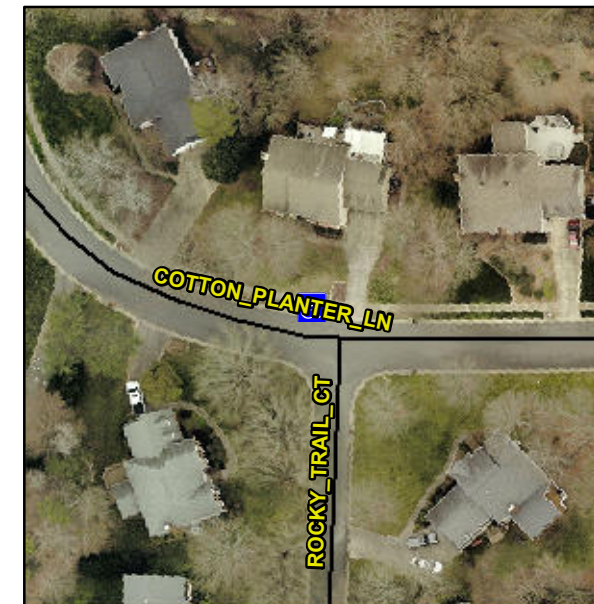
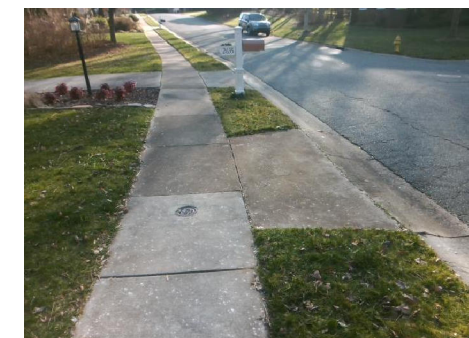
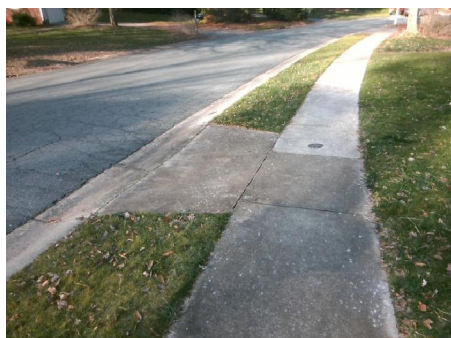
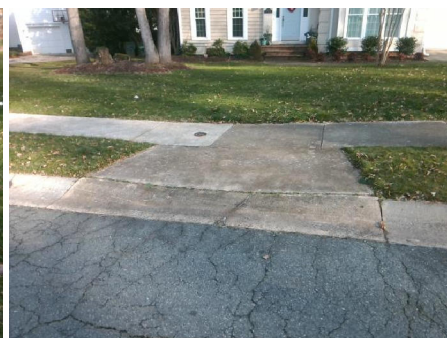
**Not Found, R304.5.3**

Compliance	Description	Data	Compliance	Description	Data
N/A	Ramp Length (in)	49.0	Yes	Ramp Slope (%)	5.5
Yes	Ramp Width (in)	48.0	No	Ramp XSlope (%)	6.5
N/A	Flare Type LT	N/A	N/A	Flare Type RT	N/A
N/A	Flare Slope LT (%)	N/A	N/A	Flare Slope RT (%)	N/A
N/A	Flare Traversable LT?	N/A	N/A	Flare Traversable RT?	N/A
N/A	Landing Length (in)	N/A	N/A	DWS Provided?	N/A
N/A	Landing Width (in)	N/A	N/A	DWS Contrast?	N/A
N/A	Landing Slope (%)	N/A	N/A	DWS Length (in)	N/A
N/A	Landing X Slope (%)	N/A	N/A	DWS Full Width?	N/A
N/A	Landing Curb? (Y/N)	N/A	N/A	DWS Offset (in)	N/A
N/A	Shared Landing?	N/A			
N/A	Gutter Ponding?	N/A	N/A	Gutter Slope (%)	N/A
N/A	Gutter Lip Ht (in)	N/A	N/A	Gutter X Slope (%)	N/A
N/A	Painted X Walk1?	No	N/A	Painted X Walk2?	N/A
	X Walk 1 Direction	To S		X Walk 2 Direction	N/A
N/A	X Walk 1 Width (in)	N/A	N/A	X Walk 2 Width (in)	N/A
	X Walk 1 Slope (%)	5.9		X Walk 2 Slope (%)	N/A
	X Walk 1 X Slope (%)	4.5		X Walk 2 X Slope (%)	N/A

N/A	Ramp inside XWalk1?	N/A	N/A	Ramp inside XWalk2?	N/A
	Road Slope (%)	N/A	N/A	Clear Space?	N/A
	Road X Slope (%)	N/A	N/A	Clear Space to XWalk (in)	N/A
N/A	Any Obstructions?	N/A	N/A	Storm Grate/Utility Hazard?	N/A
	Obstruction Type			Storm Grate/Utility Type	
		N/A			N/A
		Yes		Surface Condition? (G/P)	Good

**Remove & Replace Entire Ramp.**
