# Access Compliance Report

## Public Rights-of-Way (Curb Ramps)

| Intersection ID: 13189 | Main Street: HAWTHORNE_LN | Cross Street: SUNNYSIDE_AV | Location: NE |
| ADA ID: E805562C7000 | Ramp Type: Directional1 | Initial Pass/Fail: Pass | Overall Compliance: No |

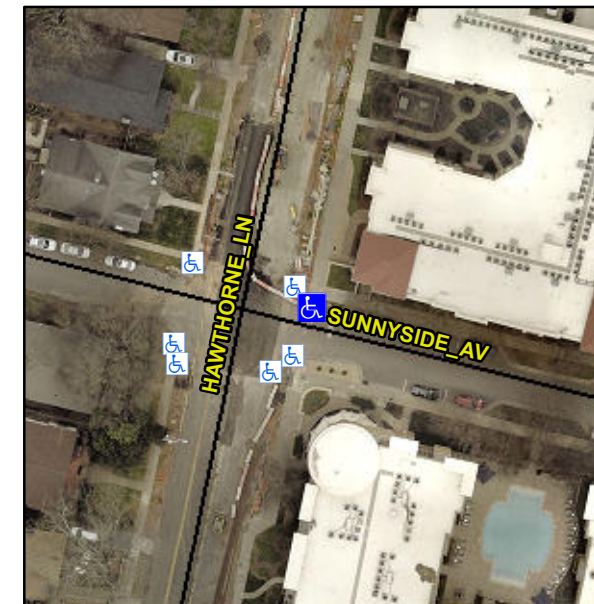
| | | Severity Score: 7.5 | |

**R305.1.4, R304.5.4, R302.3, R402.2**

| Compliance | Description | Data | Compliance | Description | Data |
|---|---|---|---|---|---|
| Yes | Landing X Slope (%) | 1.0 | No | DWS Full Width? | No |
| Yes | Gutter Ponding? | No | No | Gutter Slope (%) | 9.7 |

Possible Solutions:

**Remove & Replace Detectable Warning System. Remove & Replace Gutter. Utility Present.**
