Access Compliance Report

Public Rights-of-Way

(Curb Ramps)

Intersection ID: 48900	Main Street: PENNACOOK_DR	Cross Street: NATICK_DR	Location: E
ADA ID: E80BED724EFB	Ramp Type: Perp	Initial Pass/Fail: Fail	Overall Compliance: No
		Severity Score: 22.5

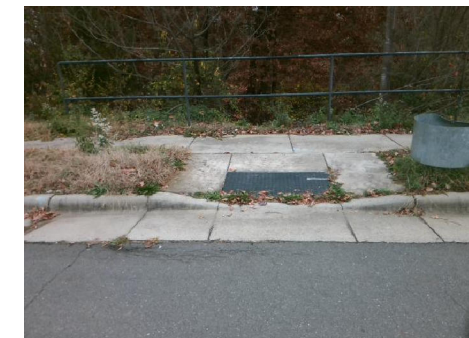
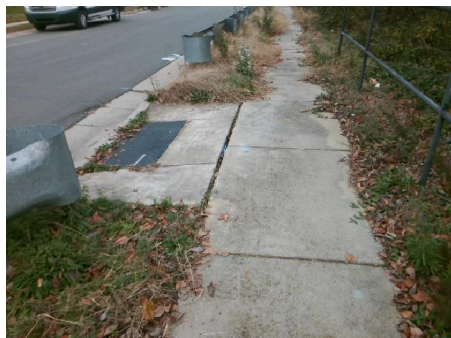
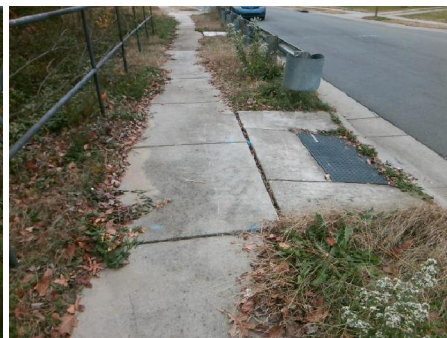
Not Found, R304.5.1, R304.2.2

Compliance	Description	Data	Compliance	Description	Data
N/A	Ramp Length (in)	50.0	No	Ramp Slope (%)	10.4
No	Ramp Width (in)	47.5	Yes	Ramp XSlope (%)	2.3
N/A	Flare Type LT	N/A	N/A	Flare Type RT	N/A
N/A	Flare Slope LT (%)	N/A	N/A	Flare Slope RT (%)	N/A
N/A	Flare Traversable LT?	N/A	N/A	Flare Traversable RT?	N/A
N/A	Landing Length (in)	N/A	N/A	DWS Provided?	N/A
N/A	Landing Width (in)	N/A	N/A	DWS Contrast?	N/A
N/A	Landing Slope (%)	N/A	N/A	DWS Length (in)	N/A
N/A	Landing X Slope (%)	N/A	N/A	DWS Full Width?	N/A
N/A	Landing Curb? (Y/N)	N/A	N/A	DWS Offset (in)	N/A
N/A	Shared Landing?	N/A			
N/A	Gutter Ponding?	N/A	N/A	Gutter Slope (%)	N/A
N/A	Gutter Lip Ht (in)	N/A	N/A	Gutter X Slope (%)	N/A
N/A	Painted X Walk1?	No	N/A	Painted X Walk2?	N/A
	X Walk 1 Direction	To W		X Walk 2 Direction	N/A
N/A	X Walk 1 Width (in)	N/A	N/A	X Walk 2 Width (in)	N/A
	X Walk 1 Slope (%)	2.3		X Walk 2 Slope (%)	N/A
	X Walk 1 X Slope (%)	2.4		X Walk 2 X Slope (%)	N/A

Remove & Replace Entire Ramp.
