Access Compliance Report

Public Rights-of-Way

(Curb Ramps)

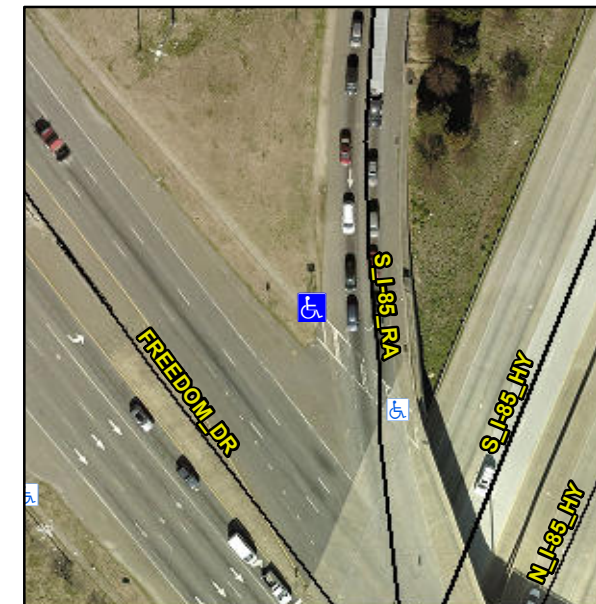
Intersection ID: N/A	Main Street: FREEDOM_DR	Cross Street: S_I-85_RA	Location:	E
ADA ID: E80C072D716E	Ramp Type: Directional1	Initial Pass/Fail: Pass	Overall Compliance: No	Severity Score: 10
Codes/Mitigation Info/Possible Solution		Field Measurements/Component Compliance

Compliance	Description	Data	Compliance	Description	Data
N/A	Ramp Length (in)	60.0	Yes	Grade Break?	Yes
Yes	Ramp Width (in)	60.0	Yes	Grade Break Slope (%)	1.0
Yes	Ramp Slope (%)	0.5	Yes	Grade Break XSlope (%)	1.9
Yes	Ramp XSlope (%)	1.2			
N/A	Flare Type LT	N/A	N/A	Flare Type RT	N/A
N/A	Flare Slope LT (%)	N/A	N/A	Flare Slope RT (%)	N/A
N/A	Flare Traversable LT?	N/A	N/A	Flare Traversable RT?	N/A
Yes	Landing Length (in)	60.0	No	DWS Provided?	No
Yes	Landing Width (in)	60.0	N/A	DWS Contrast?	No
Yes	Landing Slope (%)	1.2	N/A	DWS Length (in)	N/A
Yes	Landing X Slope (%)	0.6	N/A	DWS Full Width?	No
N/A	Landing Curb? (Y/N)	N/A	N/A	DWS Offset LT (in)	N/A
N/A	Shared Landing?	No	N/A	DWS Offset RT (in)	N/A
Yes	Gutter Ponding?	No	Yes	Gutter Slope (%)	3.4
Yes	Gutter Lip Ht (in)	0.0	Yes	Gutter X Slope (%)	0.4
N/A	Painted X Walk1?	Yes		Road Slope (%)	2.4
	X Walk 1 Direction	To SE		Road X Slope (%)	1.3
	X Walk 1 Width (in)	110.0		Clear Space?	Yes

X Walk 1 Slope (%)	2.4	N/A	Clear Space to XWalk (in)	N/A
	X Walk 1 X Slope (%)	1.3	Yes	Storm Grate/Utility Hazard?	No
Yes	Ramp inside XWalk1?	Yes		Storm Grate/Utility Type	
Yes	Any Obstructions?	No			N/A
	Obstruction Type		Yes	Surface Condition? (G/P)	Good
			N/A	Curb Slope (%)	1.6

Possible Solutions:

Install Detectable Warning System.
