Access Compliance Report

Public Rights-of-Way

(Curb Ramps)

Intersection ID: 10910	Main Street: N_SUMMIT_AV	Cross Street: W_5TH_ST	Location:	N
ADA ID: E80C2C95E090	Ramp Type: BlendTrans1	Initial Pass/Fail: Fail	Overall Compliance: No	Severity Score: 25

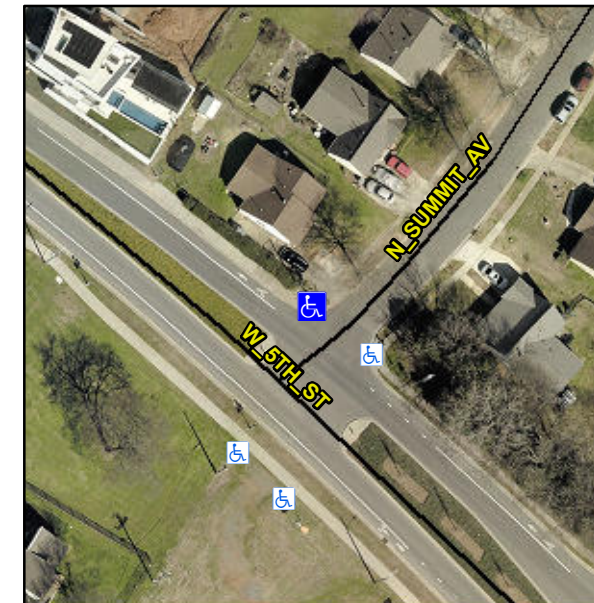
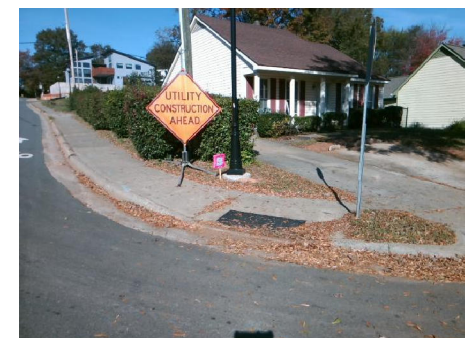
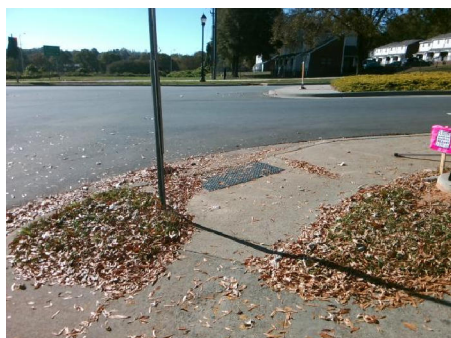
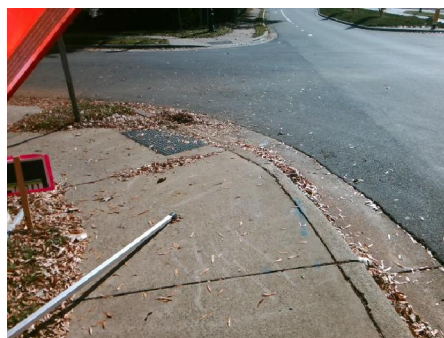
Not Found, R304.5.3

Compliance	Description	Data	Compliance	Description	Data
N/A	Ramp Length (in)	39.0	Yes	BlendTrans Slope (%)	4.7
Yes	Ramp Width (in)	50.0	No	BlendTrans XSlope (%)	7.1
N/A	Flare Type LT	N/A	N/A	Flare Type RT	N/A
N/A	Flare Slope LT (%)	N/A	N/A	Flare Slope RT (%)	N/A
N/A	Flare Traversable LT?	N/A	N/A	Flare Traversable RT?	N/A
N/A	Landing Length (in)	N/A	N/A	DWS Provided?	N/A
N/A	Landing Width (in)	N/A	N/A	DWS Contrast?	N/A
N/A	Landing Slope (%)	N/A	N/A	DWS Length (in)	N/A
N/A	Landing X Slope (%)	N/A	N/A	DWS Full Width?	N/A
N/A	Landing Curb? (Y/N)	N/A	N/A	DWS Offset (in)	N/A
N/A	Shared Landing?	N/A			
N/A	Gutter Ponding?	N/A	N/A	Gutter Slope (%)	N/A
N/A	Gutter Lip Ht (in)	N/A	N/A	Gutter X Slope (%)	N/A
N/A	Painted X Walk1?	No	N/A	Painted X Walk2?	No
	X Walk 1 Direction	To SW		X Walk 2 Direction	To SE
	X Walk 1 Width (in)	N/A		X Walk 2 Width (in)	N/A
	X Walk 1 Slope (%)	8.3		X Walk 2 Slope (%)	3.1
	X Walk 1 X Slope (%)	4.7		X Walk 2 X Slope (%)	8.4

N/A	Ramp inside XWalk1?	N/A	N/A	Ramp inside XWalk2?	N/A
	Road Slope (%)	7.3		Clear Space?	N/A
	Road X Slope (%)	5.0	N/A	Clear Space to XWalk (in)	N/A
N/A	Any Obstructions?	N/A	N/A	Storm Grate/Utility Hazard?	N/A
	Obstruction Type			Storm Grate/Utility Type	
		N/A			N/A
			Yes	Surface Condition? (G/P)	Good
			No	Curb Slope (%)	11.3

Remove & Replace Curb Ramp With Two New Directional Ramps or Equivalent.
