# Access Compliance Report

## Public Rights-of-Way

### (Curb Ramps)

| Intersection ID: 42474 | Main Street: SIR_CHARLES_PL | Cross Street: WINDSOR_CASTLE_LN | Location: | N |

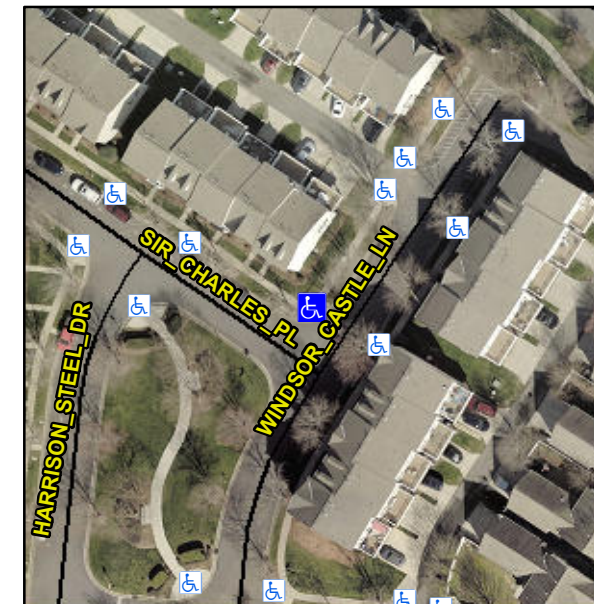
| ADA ID: E80F2FD64D74 | Ramp Type: BlendTrans1 | Initial Pass/Fail: Fail | Overall Compliance: No | Severity Score: 30 |

**R304.5.1, R304.5.3**

| Compliance | Description | Data | Compliance | Description | Data |
|---|---|---|---|---|---|
| N/A | Ramp Length (in) | 87.0 | Yes | BlendTrans Slope (%) | 4.0 |
| No | Ramp Width (in) | 33.0 | No | BlendTrans XSlope (%) | 6.3 |

**Remove & Replace Curb Ramp With Two New Directional Ramps or Equivalent.**

Total Cost: \$ 3200.00
