Access Compliance Report

Public Rights-of-Way

(Curb Ramps)

Intersection ID: 30137	Main Street: DIETRICH_LN	Cross Street: RUMPLE_RD	Location:	N
ADA ID: E81300DCA2BE	Ramp Type: PerpDiag	Initial Pass/Fail: Fail	Overall Compliance: No	Severity Score: 10

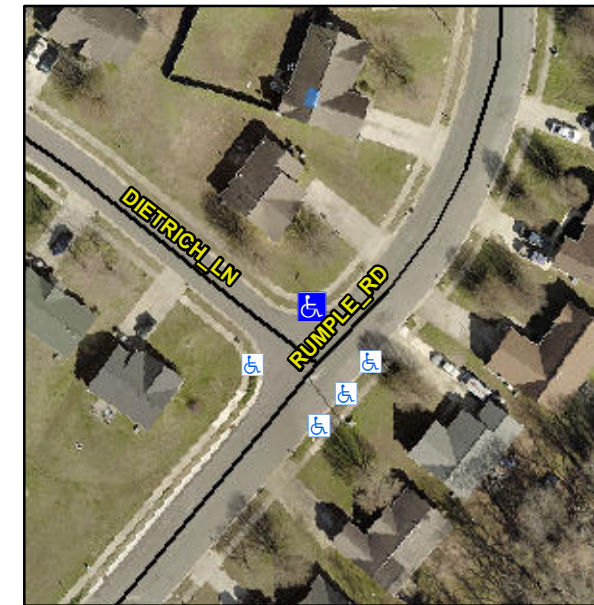
Not Found, R304.5.1, R304.5.3

Compliance	Description	Data	Compliance	Description	Data
N/A	Ramp Length (in)	48.0	Yes	Ramp Slope (%)	5.7
No	Ramp Width (in)	37.0	No	Ramp XSlope (%)	3.8
N/A	Flare Type LT	N/A	N/A	Flare Type RT	N/A
N/A	Flare Slope LT (%)	N/A	N/A	Flare Slope RT (%)	N/A
N/A	Flare Traversable LT?	N/A	N/A	Flare Traversable RT?	N/A
N/A	Landing Length (in)	N/A	N/A	DWS Provided?	N/A
N/A	Landing Width (in)	N/A	N/A	DWS Contrast?	N/A
N/A	Landing Slope (%)	N/A	N/A	DWS Length (in)	N/A
N/A	Landing X Slope (%)	N/A	N/A	DWS Full Width?	N/A
N/A	Landing Curb? (Y/N)	N/A	N/A	DWS Offset (in)	N/A
N/A	Shared Landing?	N/A			
N/A	Gutter Ponding?	N/A	N/A	Gutter Slope (%)	N/A
N/A	Gutter Lip Ht (in)	N/A	N/A	Gutter X Slope (%)	N/A
N/A	Painted X Walk1?	No	N/A	Painted X Walk2?	No
	X Walk 1 Direction	To SW		X Walk 2 Direction	To SE
N/A	X Walk 1 Width (in)	N/A	N/A	X Walk 2 Width (in)	N/A
	X Walk 1 Slope (%)	2.4		X Walk 2 Slope (%)	0.4
	X Walk 1 X Slope (%)	3.0		X Walk 2 X Slope (%)	3.5

N/A	Ramp inside XWalk1?	N/A	N/A	Ramp inside XWalk2?	N/A
	Road Slope (%)	3.0	N/A	Clear Space?	N/A
	Road X Slope (%)	1.1	N/A	Clear Space to XWalk (in)	N/A
N/A	Any Obstructions?	N/A	N/A	Storm Grate/Utility Hazard?	N/A
	Obstruction Type			Storm Grate/Utility Type	
		N/A			N/A
		Yes		Surface Condition? (G/P)	Good

Remove & Replace Curb Ramp With Two New Directional Ramps or Equivalent.
