Access Compliance Report

Public Rights-of-Way

(Curb Ramps)

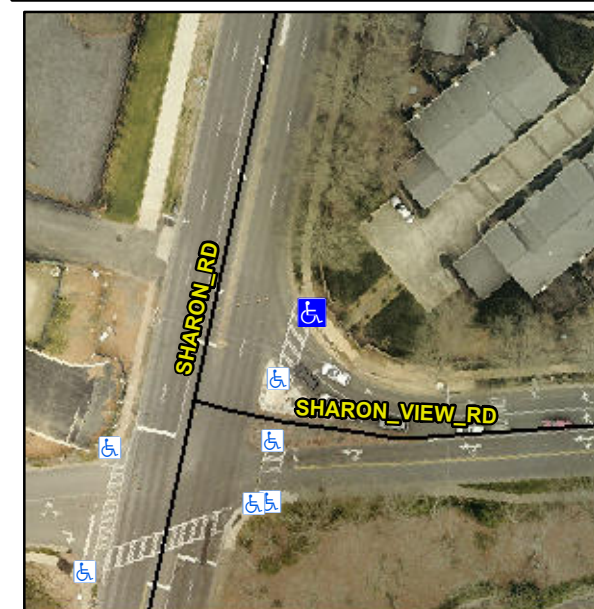
Intersection ID: 20760	Main Street: SHARON_RD	Cross Street: SHARON_VIEW_RD	Location: NE
ADA ID: E81561D67920	Ramp Type: PerpDiag	Initial Pass/Fail: Fail	Overall Compliance: No
Severity Score: 13.75			
Codes/Mitigation Info/Possible Solution		Field Measurements/Component Compliance

Not Found, R304.2.2, R304.5.3

Compliance	Description	Data	Compliance	Description	Data
N/A	Ramp Length (in)	88.0	No	Ramp Slope (%)	9.0
Yes	Ramp Width (in)	48.0	No	Ramp XSlope (%)	3.6
N/A	Flare Type LT	N/A	N/A	Flare Type RT	N/A
N/A	Flare Slope LT (%)	N/A	N/A	Flare Slope RT (%)	N/A
N/A	Flare Traversable LT?	N/A	N/A	Flare Traversable RT?	N/A
N/A	Landing Length (in)	N/A	N/A	DWS Provided?	N/A
N/A	Landing Width (in)	N/A	N/A	DWS Contrast?	N/A
N/A	Landing Slope (%)	N/A	N/A	DWS Length (in)	N/A
N/A	Landing X Slope (%)	N/A	N/A	DWS Full Width?	N/A
N/A	Landing Curb? (Y/N)	N/A	N/A	DWS Offset (in)	N/A
N/A	Shared Landing?	N/A			
N/A	Gutter Ponding?	N/A	N/A	Gutter Slope (%)	N/A
N/A	Gutter Lip Ht (in)	N/A	N/A	Gutter X Slope (%)	N/A
N/A	Painted X Walk1?	No	N/A	Painted X Walk2?	Yes
	X Walk 1 Direction	To W		X Walk 2 Direction	To SW
N/A	X Walk 1 Width (in)	N/A	N/A	X Walk 2 Width (in)	110.0
	X Walk 1 Slope (%)	0.2		X Walk 2 Slope (%)	0.9
	X Walk 1 X Slope (%)	0.2		X Walk 2 X Slope (%)	0.5

N/A	Ramp inside XWalk1?	N/A	N/A	Ramp inside XWalk2?	Yes
	Road Slope (%)	0.3	N/A	Clear Space?	N/A
	Road X Slope (%)	0.2	N/A	Clear Space to XWalk (in)	N/A
N/A	Any Obstructions?	N/A	N/A	Storm Grate/Utility Hazard?	N/A
	Obstruction Type			Storm Grate/Utility Type	
		N/A			N/A
		Yes		Surface Condition? (G/P)	Good

Remove & Replace Curb Ramp With Two New Directional Ramps or Equivalent.
