# Access Compliance Report

## Public Rights-of-Way

### (Curb Ramps)

Intersection ID: 10027413	Main Street: GOLF_LINKS_DR_N	Cross Street: N/A	Location: SE
ADA ID: E8243B18913E	Ramp Type: Perp	Initial Pass/Fail: Fail	Overall Compliance: No
Severity Score: 1.25			
Codes/Mitigation Info/Possible Solution		Field Measurements/Component Compliance

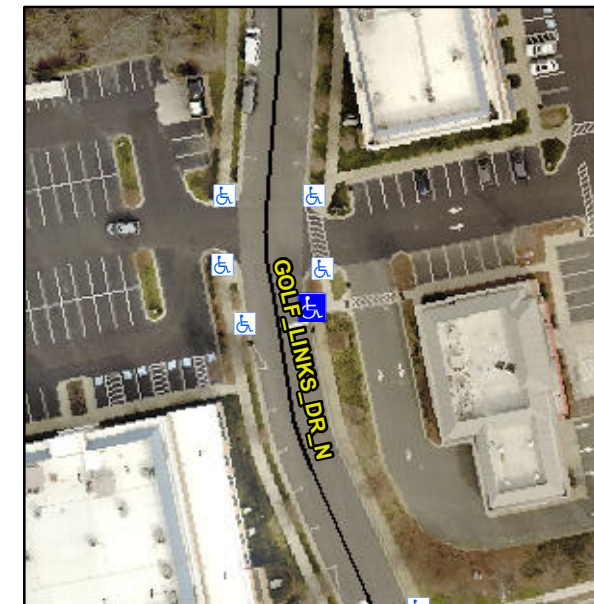
**Not Found, R304.5.3**

Compliance	Description	Data	Compliance	Description	Data
N/A	Ramp Length (in)	60.0	Yes	Ramp Slope (%)	7.3
Yes	Ramp Width (in)	62.0	No	Ramp XSlope (%)	2.3
N/A	Flare Type LT	N/A	N/A	Flare Type RT	N/A
N/A	Flare Slope LT (%)	N/A	N/A	Flare Slope RT (%)	N/A
N/A	Flare Traversable LT?	N/A	N/A	Flare Traversable RT?	N/A
N/A	Landing Length (in)	N/A	N/A	DWS Provided?	N/A
N/A	Landing Width (in)	N/A	N/A	DWS Contrast?	N/A
N/A	Landing Slope (%)	N/A	N/A	DWS Length (in)	N/A
N/A	Landing X Slope (%)	N/A	N/A	DWS Full Width?	N/A
N/A	Landing Curb? (Y/N)	N/A	N/A	DWS Offset (in)	N/A
N/A	Shared Landing?	N/A			
N/A	Gutter Ponding?	N/A	N/A	Gutter Slope (%)	N/A
N/A	Gutter Lip Ht (in)	N/A	N/A	Gutter X Slope (%)	N/A
N/A	Painted X Walk1?	No	N/A	Painted X Walk2?	N/A
	X Walk 1 Direction	To W		X Walk 2 Direction	N/A
N/A	X Walk 1 Width (in)	N/A	N/A	X Walk 2 Width (in)	N/A
	X Walk 1 Slope (%)	2.9		X Walk 2 Slope (%)	N/A
	X Walk 1 X Slope (%)	0.7		X Walk 2 X Slope (%)	N/A

N/A	Ramp inside XWalk1?	N/A	N/A	Ramp inside XWalk2?	N/A
	Road Slope (%)	N/A	N/A	Clear Space?	N/A
	Road X Slope (%)	N/A	N/A	Clear Space to XWalk (in)	N/A
N/A	Any Obstructions?	N/A	N/A	Storm Grate/Utility Hazard?	N/A
	Obstruction Type			Storm Grate/Utility Type	
		N/A			N/A
			Yes	Surface Condition? (G/P)	Good

**Remove & Replace Entire Ramp.**

Total Cost: \$ 1850.00
