# Access Compliance Report

## Public Rights-of-Way

### (Curb Ramps)

| Intersection ID: 11917 | Main Street: MIMOSA_AV | Cross Street: THURMOND_PL | Location: NW |

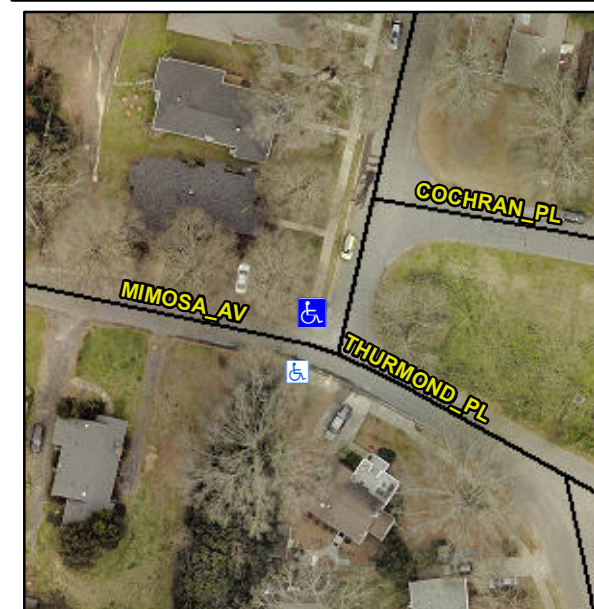
**Not Found, R304.2.1, R304.5.3,  
R305.1.4, R305.2, R302.7.2**

| Compliance | Description | Data | Compliance | Description | Data |
|---|---|---|---|---|---|
| Yes | Ramp Slope (%) | 2.2 | No | Grade Break XSlope (%) | 4.5 |
| No | Landing Length (in) | 36.5 | Yes | DWS Provided? | Yes |
| No | Landing X Slope (%) | 2.1 | No | DWS Full Width? | No |
| No | Gutter Lip Ht (in) | 0.5 | No | Gutter X Slope (%) | 4.3 |

Possible Solutions:

**Remove & Replace Entire Ramp.  
Remove & Replace Gutter.**
