# Access Compliance Report

## Public Rights-of-Way

### (Curb Ramps)

Intersection ID: 43869	Main Street: CALDWELL_RIDGE_PY	Cross Street: SIDNEY_CREST_AV	Location: NW
ADA ID: E83894F4B7ED	Ramp Type: Perp	Initial Pass/Fail: Fail	Overall Compliance: No
			Severity Score: 21.25

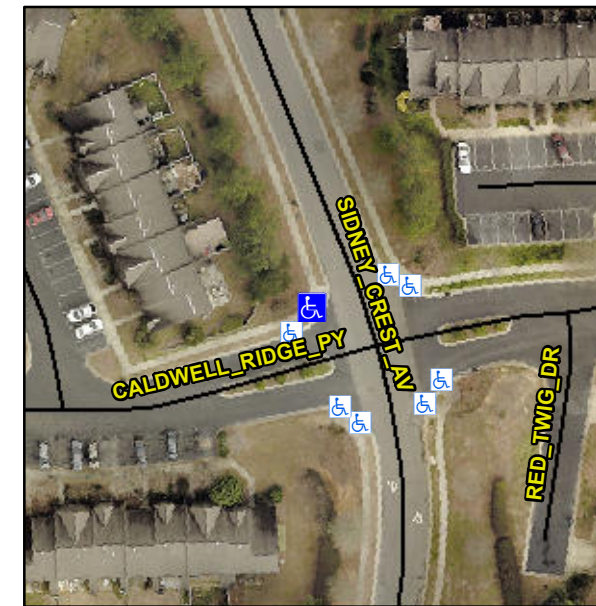
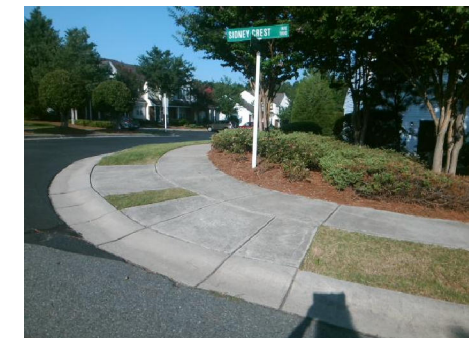
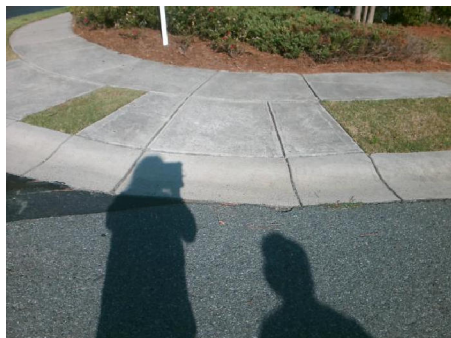
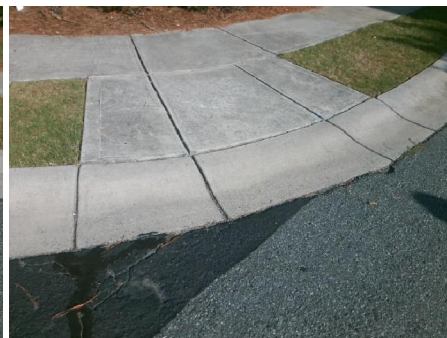
**Not Found, R304.5.1, R304.5.3**

Compliance	Description	Data	Compliance	Description	Data
N/A	Ramp Length (in)	49.5	Yes	Ramp Slope (%)	5.4
No	Ramp Width (in)	36.0	No	Ramp XSlope (%)	6.8
N/A	Flare Type LT	N/A	N/A	Flare Type RT	N/A
N/A	Flare Slope LT (%)	N/A	N/A	Flare Slope RT (%)	N/A
N/A	Flare Traversable LT?	N/A	N/A	Flare Traversable RT?	N/A
N/A	Landing Length (in)	N/A	N/A	DWS Provided?	N/A
N/A	Landing Width (in)	N/A	N/A	DWS Contrast?	N/A
N/A	Landing Slope (%)	N/A	N/A	DWS Length (in)	N/A
N/A	Landing X Slope (%)	N/A	N/A	DWS Full Width?	N/A
N/A	Landing Curb? (Y/N)	N/A	N/A	DWS Offset (in)	N/A
N/A	Shared Landing?	N/A			
N/A	Gutter Ponding?	N/A	N/A	Gutter Slope (%)	N/A
N/A	Gutter Lip Ht (in)	N/A	N/A	Gutter X Slope (%)	N/A
N/A	Painted X Walk1?	No	N/A	Painted X Walk2?	N/A
	X Walk 1 Direction	To E		X Walk 2 Direction	N/A
N/A	X Walk 1 Width (in)	N/A	N/A	X Walk 2 Width (in)	N/A
	X Walk 1 Slope (%)	3.9		X Walk 2 Slope (%)	N/A
	X Walk 1 X Slope (%)	6.3		X Walk 2 X Slope (%)	N/A

N/A	Ramp inside XWalk1?	N/A	N/A	Ramp inside XWalk2?	N/A
	Road Slope (%)	N/A	N/A	Clear Space?	N/A
	Road X Slope (%)	N/A	N/A	Clear Space to XWalk (in)	N/A
N/A	Any Obstructions?	N/A	N/A	Storm Grate/Utility Hazard?	N/A
	Obstruction Type			Storm Grate/Utility Type	
		N/A			N/A
			Yes	Surface Condition? (G/P)	Good

**Remove & Replace Entire Ramp.**
