Access Compliance Report

Public Rights-of-Way

(Curb Ramps)

Intersection ID: 50450	Main Street: ELIZABETH MADISON CT	Cross Street: HAWFIELD WOODS LN	Location: NW
ADA ID: E838A6810DFA	Ramp Type: Perp	Initial Pass/Fail: Fail	Overall Compliance: No
Codes/Mitigation Info/Possible Solution		Field Measurements/Component Compliance	
Severity Score: 21.25

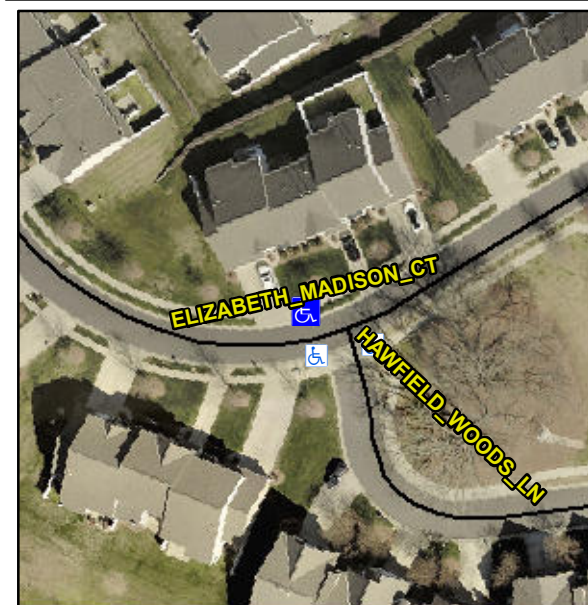
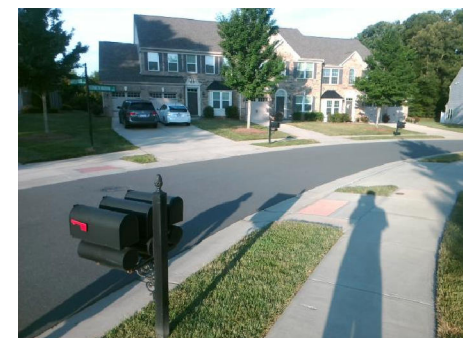
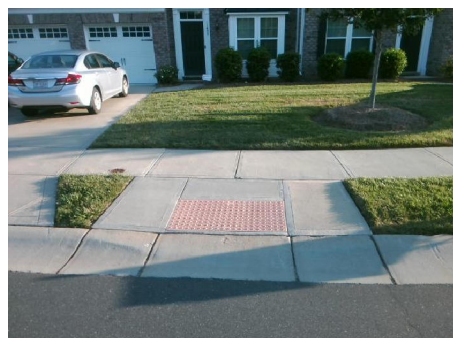
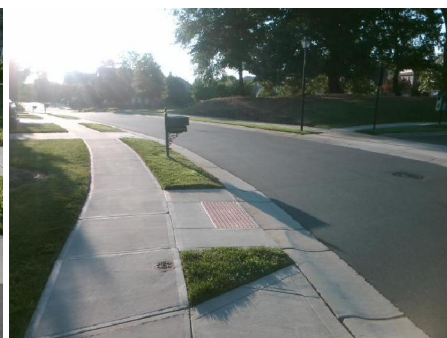
Not Found, R304.5.1, R304.2.2

Compliance	Description	Data	Compliance	Description	Data
N/A	Ramp Length (in)	48.0	No	Ramp Slope (%)	9.0
No	Ramp Width (in)	47.5	Yes	Ramp XSlope (%)	0.4
N/A	Flare Type LT	N/A	N/A	Flare Type RT	N/A
N/A	Flare Slope LT (%)	N/A	N/A	Flare Slope RT (%)	N/A
N/A	Flare Traversable LT?	N/A	N/A	Flare Traversable RT?	N/A
N/A	Landing Length (in)	N/A	N/A	DWS Provided?	N/A
N/A	Landing Width (in)	N/A	N/A	DWS Contrast?	N/A
N/A	Landing Slope (%)	N/A	N/A	DWS Length (in)	N/A
N/A	Landing X Slope (%)	N/A	N/A	DWS Full Width?	N/A
N/A	Landing Curb? (Y/N)	N/A	N/A	DWS Offset (in)	N/A
N/A	Shared Landing?	N/A			
N/A	Gutter Ponding?	N/A	N/A	Gutter Slope (%)	N/A
N/A	Gutter Lip Ht (in)	N/A	N/A	Gutter X Slope (%)	N/A
N/A	Painted X Walk1?	No	N/A	Painted X Walk2?	N/A
	X Walk 1 Direction	To S		X Walk 2 Direction	N/A
N/A	X Walk 1 Width (in)	N/A	N/A	X Walk 2 Width (in)	N/A
	X Walk 1 Slope (%)	3.3		X Walk 2 Slope (%)	N/A
	X Walk 1 X Slope (%)	1.2		X Walk 2 X Slope (%)	N/A

N/A	Ramp inside XWalk1?	N/A	N/A	Ramp inside XWalk2?	N/A
	Road Slope (%)	N/A	N/A	Clear Space?	N/A
	Road X Slope (%)	N/A	N/A	Clear Space to XWalk (in)	N/A
N/A	Any Obstructions?	N/A	N/A	Storm Grate/Utility Hazard?	N/A
	Obstruction Type			Storm Grate/Utility Type	
		N/A			N/A
			Yes	Surface Condition? (G/P)	Good

Possible Solutions:

Remove & Replace Entire Ramp.
