# Access Compliance Report

## Public Rights-of-Way

### (Curb Ramps)

Intersection ID: 20975	Main Street: DELSHIRE_LN	Cross Street: SANDY_PORTER_RD	Location: SE
ADA ID: E83FECA6863D	Ramp Type: Directional1	Initial Pass/Fail: Fail	Overall Compliance: No
Severity Score: 12.5			
Codes/Mitigation Info/Possible Solution		Field Measurements/Component Compliance

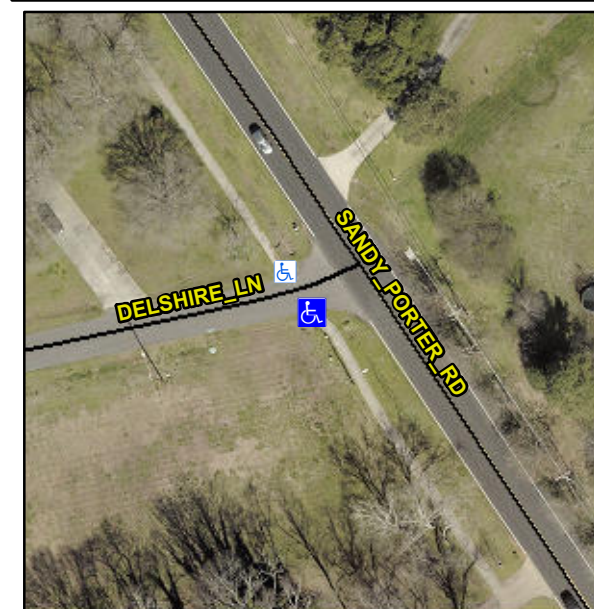
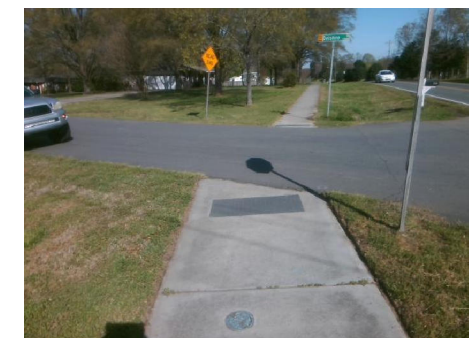
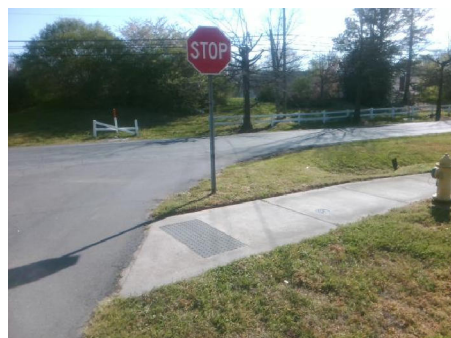
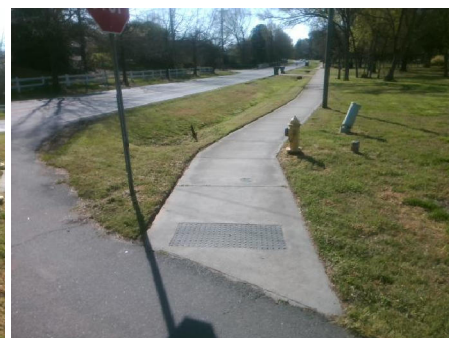
Compliance	Description	Data	Compliance	Description	Data
N/A	Ramp Length (in)	85.0	N/A	Grade Break?	N/A
Yes	Ramp Width (in)	73.0	N/A	Grade Break Slope (%)	0.0
Yes	Ramp Slope (%)	4.7	N/A	Grade Break XSlope (%)	0.0
No	Ramp XSlope (%)	5.9			
N/A	Flare Type LT	N/A	N/A	Flare Type RT	N/A
N/A	Flare Slope LT (%)	N/A	N/A	Flare Slope RT (%)	0.0
N/A	Flare Traversable LT?	N/A	N/A	Flare Traversable RT?	N/A
N/A	Landing Length (in)	0.0	N/A	DWS Provided?	N/A
N/A	Landing Width (in)	0.0	N/A	DWS Contrast?	N/A
N/A	Landing Slope (%)	0.0	N/A	DWS Length (in)	N/A
N/A	Landing X Slope (%)	0.0	N/A	DWS Full Width?	N/A
N/A	Landing Curb? (Y/N)	N/A	N/A	DWS Offset LT (in)	N/A
N/A	Shared Landing?	N/A	N/A	DWS Offset RT (in)	N/A
N/A	Gutter Ponding?	0.0	N/A	Gutter Slope (%)	N/A
N/A	Gutter Lip Ht (in)	0.0	N/A	Gutter X Slope (%)	N/A
N/A	Painted X Walk1?	No		Road Slope (%)	2.6
	X Walk 1 Direction	To NW		Road X Slope (%)	2.0
	X Walk 1 Width (in)	N/A		Clear Space?	N/A

X Walk 1 Slope (%)	2.6	N/A	Clear Space to XWalk (in)	N/A
	X Walk 1 X Slope (%)	2.0	N/A	Storm Grate/Utility Hazard?	N/A
N/A	Ramp inside XWalk1?	N/A		Storm Grate/Utility Type	
N/A	Any Obstructions?	N/A			N/A
	Obstruction Type		Yes	Surface Condition? (G/P)	Good
			N/A	Curb Slope (%)	3.3

Possible Solutions:

**Remove & Replace Entire Ramp.**

**R304.5.3**

\$ 1600.00
