# Access Compliance Report

## Public Rights-of-Way

### (Curb Ramps)

Intersection ID: 7456	Main Street: PONDELLA_DR	Cross Street: ROSADA_AV	Location:	N
ADA ID: E83FF0C4296E	Ramp Type: Para	Initial Pass/Fail: Fail	Overall Compliance: No	Severity Score: 12.5
Codes/Mitigation Info/Possible Solution		Field Measurements/Component Compliance

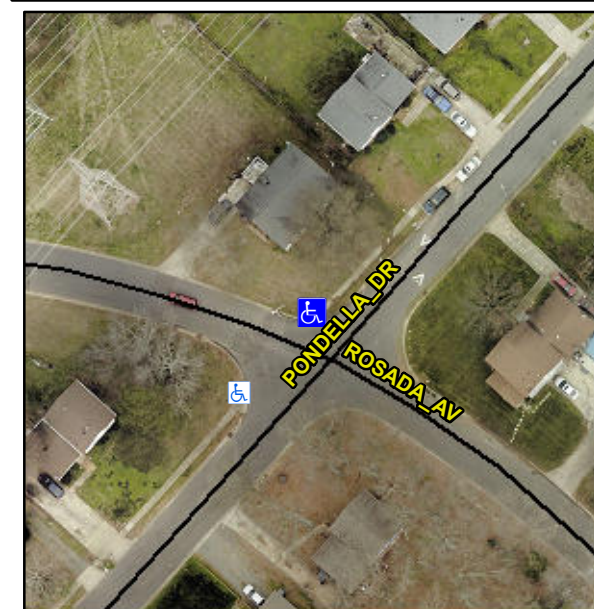
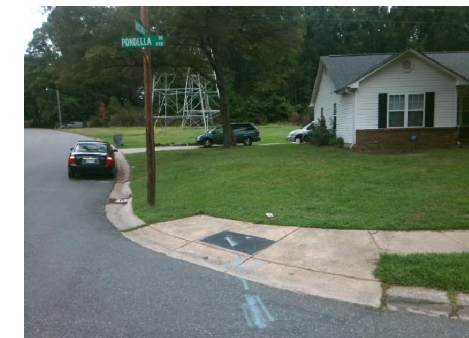
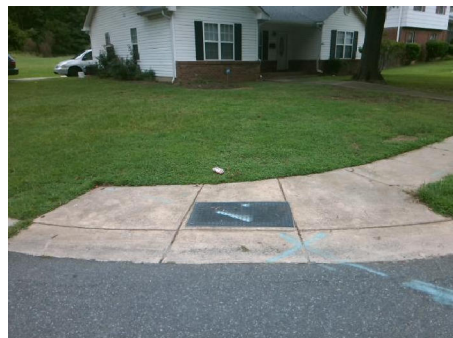
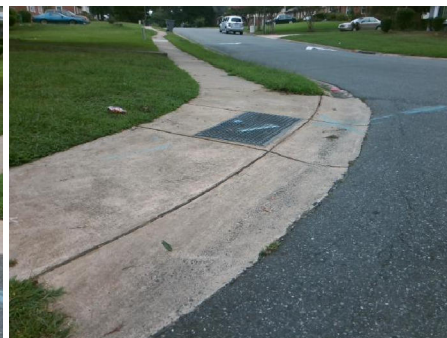
**CURB GAP 1.0, NO LT SW, RT RP < 5%**

Compliance	Description	Data	Compliance	Description	Data
N/A	Ramp Length LT (in)	63.0	N/A	Ramp Length RT (in)	43.5
Yes	Ramp Width LT (in)	48.5	Yes	Ramp Width RT (in)	51.5
Yes	Ramp Slope LT (%)	5.5	Yes	Ramp Slope RT (%)	1.9
No	Ramp XSlope LT (%)	2.8	No	Ramp XSlope RT (%)	5.1
N/A	Landing Length (in)	N/A	N/A	DWS Provided?	N/A
N/A	Landing Width (in)	N/A	N/A	DWS Contrast?	N/A
N/A	Landing Slope (%)	N/A	N/A	DWS Length (in)	N/A
N/A	Landing X Slope (%)	N/A	N/A	DWS Full Width?	N/A
N/A	Landing Curb? (Y/N)	N/A	N/A	DWS Offset (in)	N/A
N/A	Shared Landing?	N/A			
N/A	Gutter Ponding?	N/A	N/A	Gutter Slope (%)	N/A
N/A	Gutter Lip Ht (in)	N/A	N/A	Gutter X Slope (%)	N/A
N/A	Painted X Walk1?	No	N/A	Painted X Walk2?	N/A
	X Walk 1 Direction	To SW		X Walk 2 Direction	N/A
N/A	X Walk 1 Width (in)	N/A	N/A	X Walk 2 Width (in)	N/A
	X Walk 1 Slope (%)	3.4		X Walk 2 Slope (%)	N/A
	X Walk 1 X Slope (%)	3.2		X Walk 2 X Slope (%)	N/A
N/A	Ramp inside XWalk1?	N/A	N/A	Ramp inside XWalk2?	N/A

Road Slope (%)	N/A	N/A	Clear Space?	N/A
	Road X Slope (%)	N/A	N/A	Clear Space to XWalk (in)	N/A
N/A	Any Obstructions?	N/A	N/A	Storm Grate/Utility Hazard?	N/A
	Obstruction Type			Storm Grate/Utility Type	
		N/A			N/A
			Yes	Surface Condition? (G/P)	Good
			N/A	Curb Slope (%)	13.3

**Remove & Replace Entire Ramp.**
